**Humboldt  
Redwood™**

**Class I Stream Aquatic Habitat Trends  
Monitoring  
2018 Annual Report**

**June 30, 2019**

**Title:** Class I Stream Aquatic Habitat Trends Monitoring

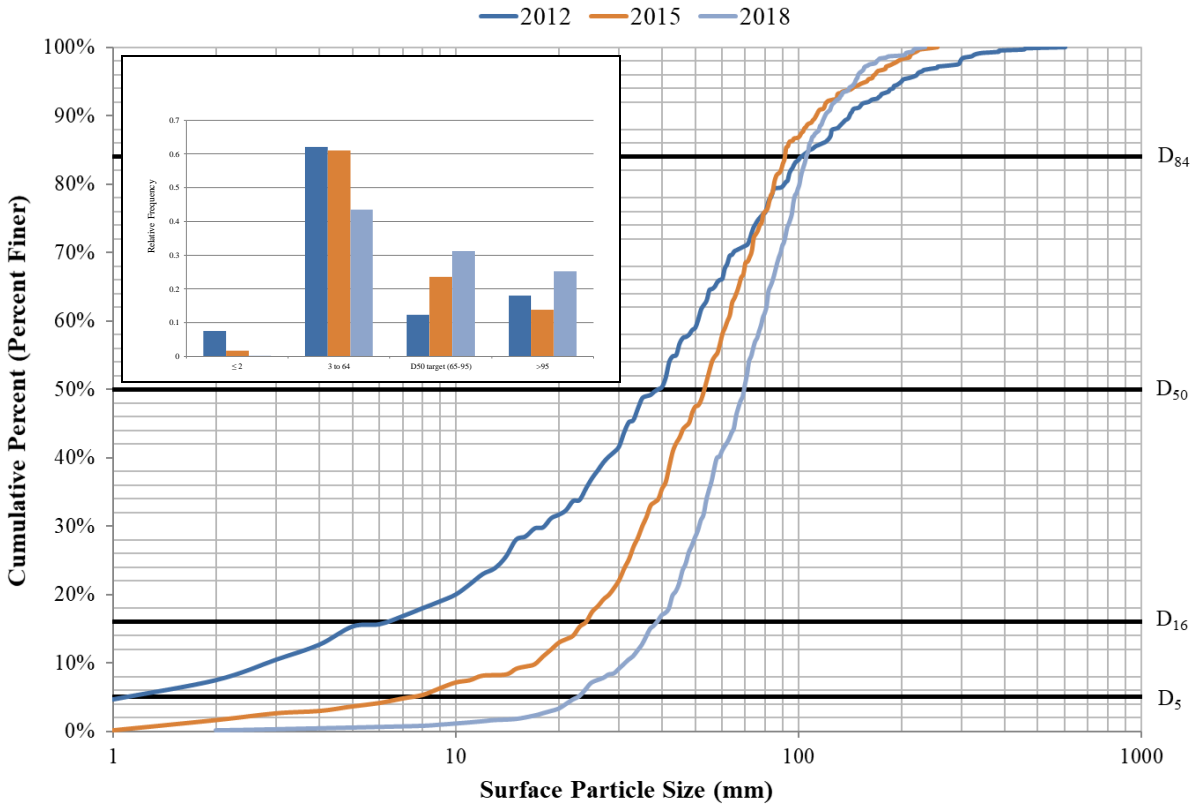
**Figure 4. Example of a cumulative frequency (percent finer) plot of the mean surface particle sizes (mm) of three riffles measured within an ATM survey reach**

established for  $D_{50}$ . Results are reported as mean values within the APFC report card, as well as cumulative particle size frequency plots (Figure 4), which serve to provide a visual aid for improved interpretation. Over time, it is expected that trends will develop that will suggest an overall fining or coarsening of the channel substrate towards APFC target values to the extent provided for by inherent watershed conditions.

Updates to pebble count analysis methodology were made in 2015 which expanded the parameters to include three (3) additional classes ( $D_5$ ,  $D_{16}$ , and  $D_{85}$ ). This was initiated as a substitute for the discontinued streambed subsurface particle size monitoring. Fining of the streambed is a concern property-wide and is a process that can be observed through pebble counts alone. If fining of the bed surface is observed, then one can assume that a similar trend is occurring in the subsurface. Results were reported as mean values within the APFC matrix, although an APFC target value has only been established for  $D_{50}$ . Additionally, cumulative frequency plots were developed to provide a visual aid for improved interpretation of the particle size distributions.

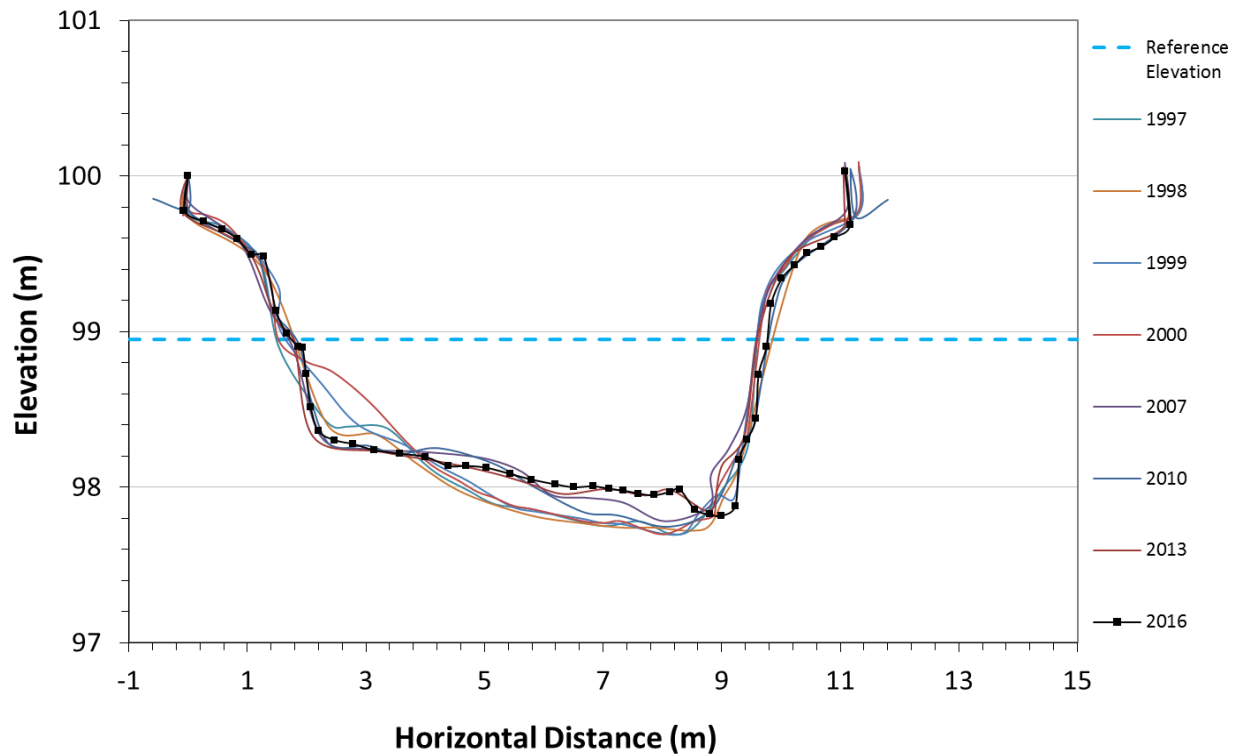
**Figure 5. Example of a typical cross-sectional profile within an ATM survey reach**

Data processing has been streamlined with electronic data collection, transfer, and processing. HRC has developed an Excel® spreadsheet to process cross-section data from x, y, z coordinates into standard measurements in the x-z plane. An additional spreadsheet computes channel area (m<sup>2</sup>), width (m) and depth (m).

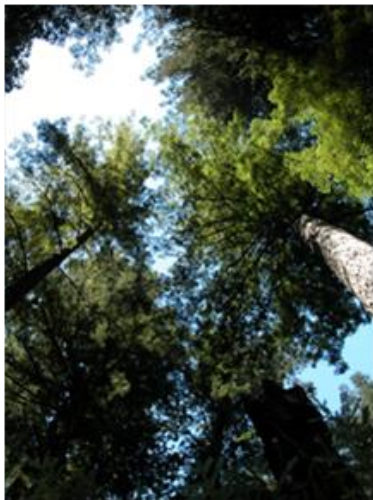
**Figure 7. Redwood riparian forest overstory**

streams that may be subject to higher thermal loading from sunlight. Canopy cover addresses the APFC matrix target for mid-channel canopy closure (Figure 6) and within the riparian forest (Figure 7). The mid-channel canopy cover is measured as an influence of the forest on maintaining cool water

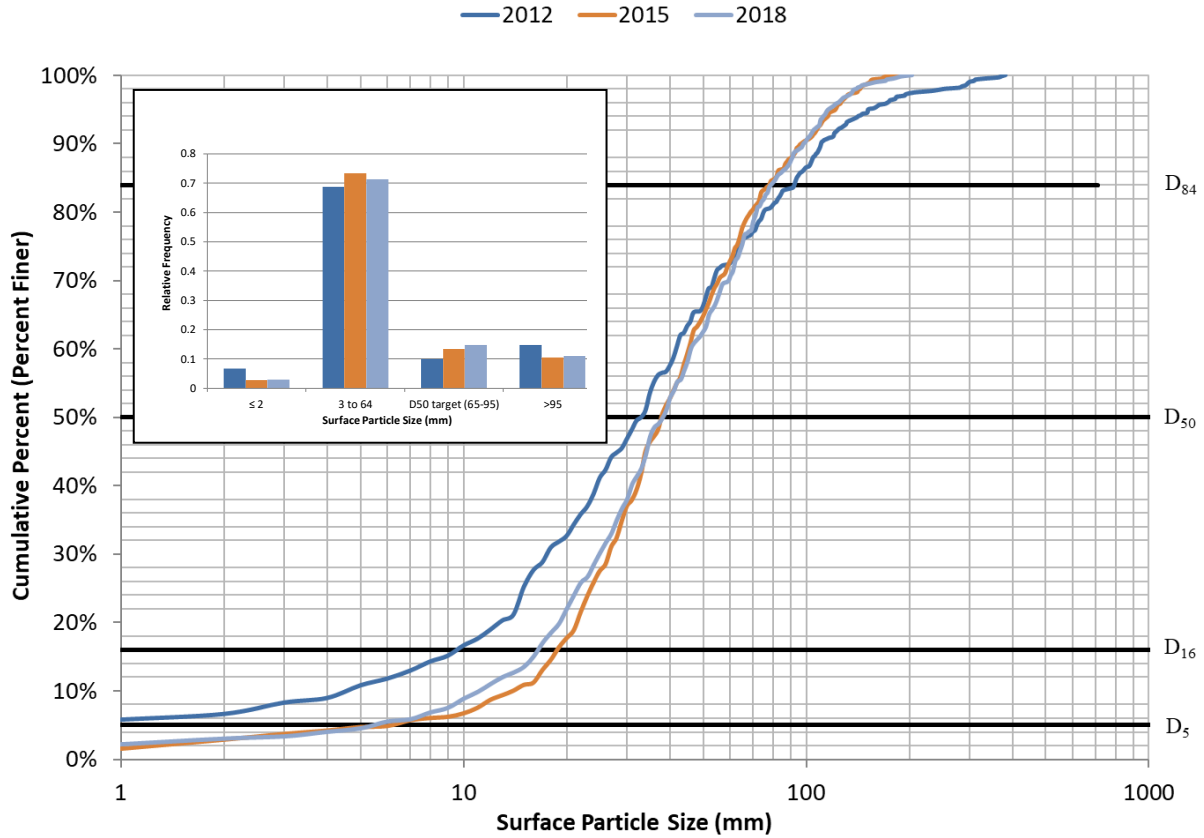
**Figure 16. Cumulative frequency plot of the mean surface particle sizes of three riffles measured within the Shaw Creek ATM 040 survey reach**

Data for all ATM parameters at site 040 (Figure 14) are summarized in the APFC report card found in Table 7. Bed surface parameters remain below APFC targets as data suggest no change in D<sub>50</sub> values since 2015. Although the D<sub>84</sub> substrate particle class appeared to coarsen slightly, there was a fining of the D<sub>16</sub> and D<sub>5</sub> substrate particle size classes (Figure 16). Pool habitats scored the same as in 2015, although values showed an increase across all individual parameters. LWD total piece frequency did not meet the target for the seventh consecutive survey year, even as data suggest an increase in the total number of pieces counted. Temperature and canopy parameters each met their target ranges.

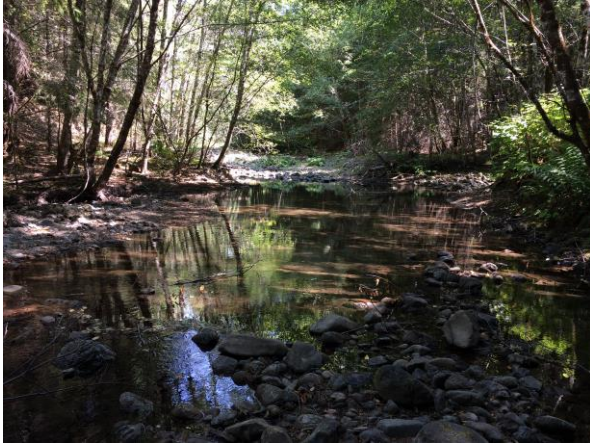
**ATM 133 Sulphur Creek**

Data for all ATM parameters at site 133 (Figure 23) are summarized in an APFC report card (Table 13). The bed surface APFC target was met in 2018, as the data suggest a coarsening of the substrate across all particle size classes (Figure 24). Pool characteristics became more favorable with 3 of 4 measured parameters meeting their target value. LWD piece counts in 2018 were fewer than twice what were measured in 2015, as total piece frequency did not meet the target for the seventh consecutive survey year. Canopy cover met the target value for the third year in a row and stream temperature met its target in 2018 after failing to meet the target in 2017.

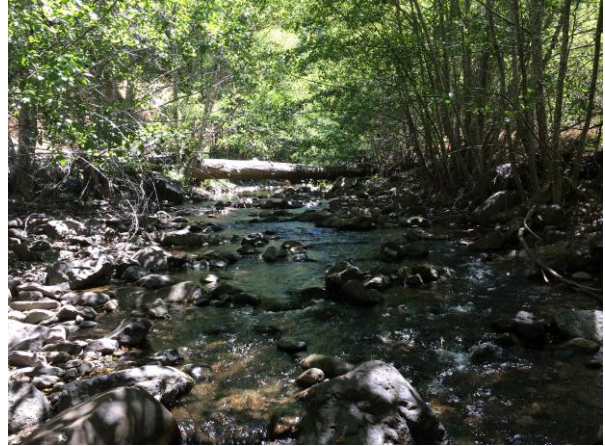
**ATM 169 Rattlesnake Creek**

Data for all ATM parameters at site 169 (Figure 23) are summarized in an APFC report card (Table 14). The bed surface APFC target was not met in 2018, as the data suggest a fining of the substrate across all particle size classes (Figure 25). Pool characteristics appear to have improved slightly, with 3/4 parameters meeting the APFC target values. LWD frequency has been historically very low in this reach, with parameters measuring well below target each survey year. Stream temperature continued to place short of the target for the seventh consecutive survey year, despite canopy cover showing an increase in 2018, meeting the APFC target for the first time on record.

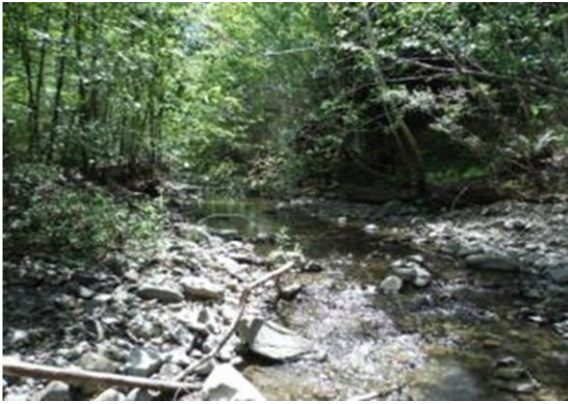
**ATM 204 Bear Creek**

Data for all ATM parameters at site 204 (Figure 29) are summarized in an APFC report card (Table 19). The bed surface APFC target was met in 2018, as the data suggest a coarsening of the substrate across most particle size classes (Figure 32). Pool habitats remained static, with 3/4 parameters meeting the target values. LWD piece frequency met the target for the fourth consecutive year. Over stream canopy cover in 2018 placed short of the target value after briefly meeting the target in 2017. Stream temperature met the target in 2018 for the third straight year.

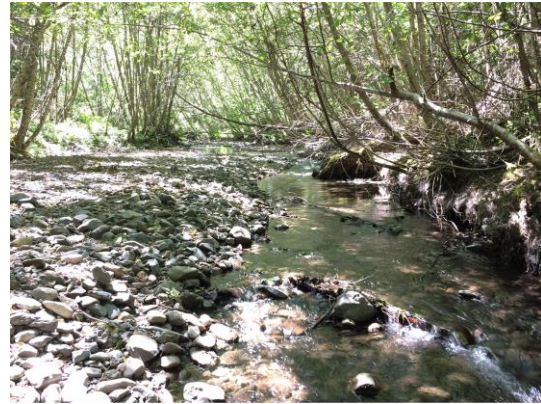
**ATM 203 Bear Creek**

Data for all ATM parameters at site 203 (Figure 29) are summarized in the APFC report card found in Table 17. The bed surface APFC target was met in 2018, as the data suggest a coarsening of the substrate across all particle size classes (Figure 30). Pool habitats remained static, with 3/4 parameters meeting the target values. LWD piece frequency met the target for the seventh consecutive year. Over stream canopy cover in 2018 placed short of the target value for the seventh consecutive year. Stream temperature did not meet the target for the second consecutive year.

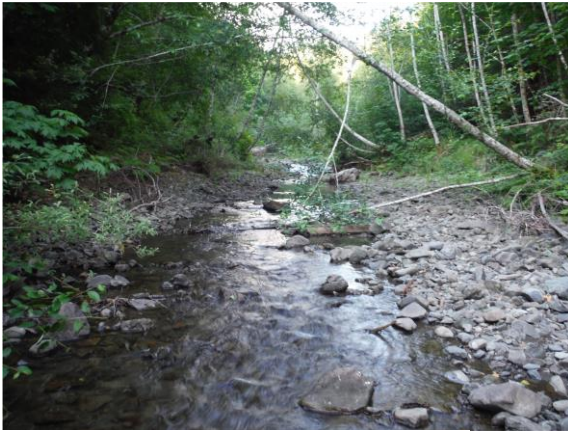
**ATM 107 Bear Creek**

Data for all ATM parameters at site 107 (Figure 29) are summarized in an APFC report card (Table 18). The bed surface APFC target was met in 2018, as the data suggest a coarsening of the substrate across all particle size classes (Figure 31). Pool habitats remained static, with 3/4 parameters meeting the target values. LWD piece frequency met the target for the third consecutive year. Over stream canopy cover in 2018 placed short of the target value for the seventh consecutive year. Stream temperature met the target in 2018 after placing short of the target by 0.01 °C in 2017.
