**Class I Stream Aquatic Habitat Trends
Monitoring
2019 Annual Report**

June 30, 2020

Title: Class I Stream Aquatic Habitat Trends Monitoring

Purpose: Habitat Conservation Plan Aquatic Monitoring

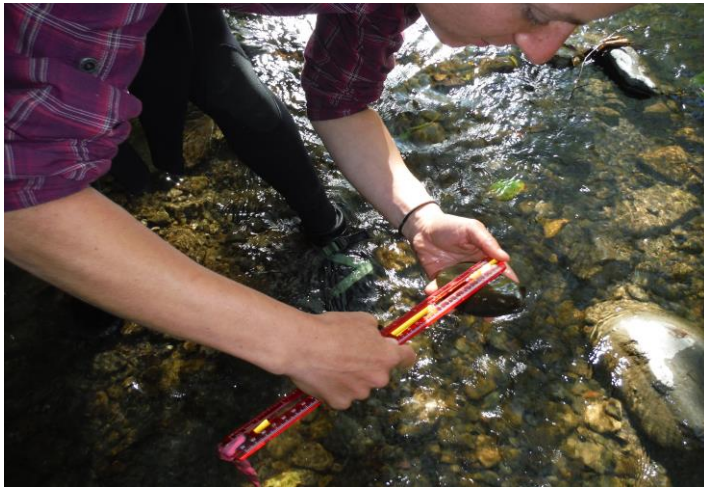
Figure 3. Measuring particle size (mm) of the streambed surface

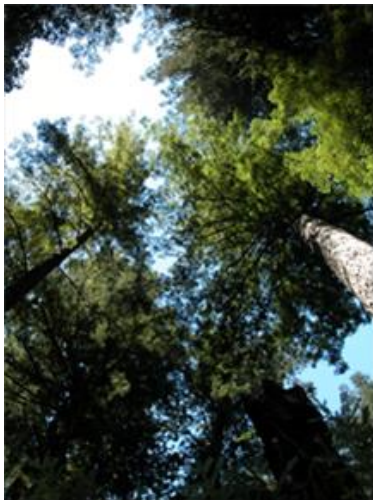
Figure 7. Redwood riparian forest overstory

streams that may be subject to higher thermal loading from sunlight. Canopy cover addresses the APFC matrix target for mid-channel canopy closure (Figure 6) and within the riparian forest (Figure 7). The mid-channel canopy cover is measured as an influence of the forest on maintaining cool water

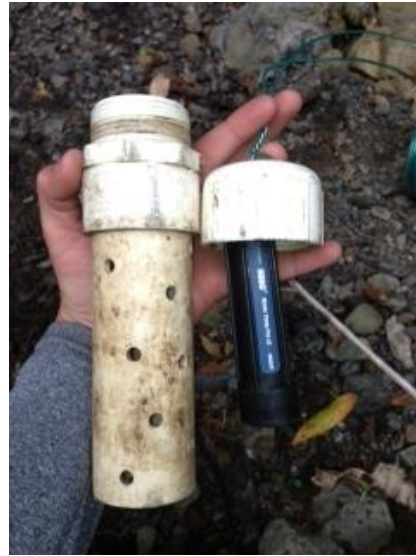
Figure 8. Stream temperature logger with protective PVC case

Stream temperature (°C) is tracked during the warmest part of the year (typically June through September). Temperature is monitored with continuous recording data loggers (Onset HOBO® Water Temp Pro v2). Temperature data loggers are inserted into protective PVC cases (Figure 8) and placed in the stream at a location that meets requirements for sufficient mixing, adequate cover, and consistent flows during the summer months to ensure data integrity by reducing the likelihood of thermal stratification. Temperature data are used to calculate the maximum weekly average temperature (MWAT), or the average of the daily mean temperature measured during the warmest seven consecutive days each year. The APFC target value for MWAT at all ATM stations is $\leq 16.8^{\circ}\text{C}$. Figure 9 illustrates a typical temperature profile as measured at ATM stations property wide.

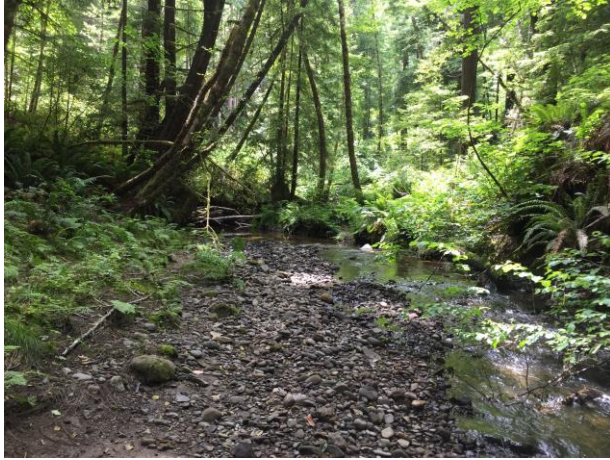
Root Creek Station 003

Data for all ATM parameters at site 003 (Figure 13) are summarized in the APFC report card provided in Table 6. The bed surface APFC target was not met at this site in 2019, as the data suggest a fining of substrate particles within classes D_{84} & D_{50} and a coarsening of the substrates within particle classes D_{16} & D_5 (Figure 14). Pool characteristics remained generally static since 2004, with residual pool depth consistently failing to meet its target criterion. Total LWD pieces decreased by 61% since 2016, as total LWD piece frequency failed to meet the APFC target by a margin of 1.3 pieces per 100 feet of stream channel. Water temperature met the target two years straight since 2017, as mid-channel canopy met the target goal after failing only once in 2016.

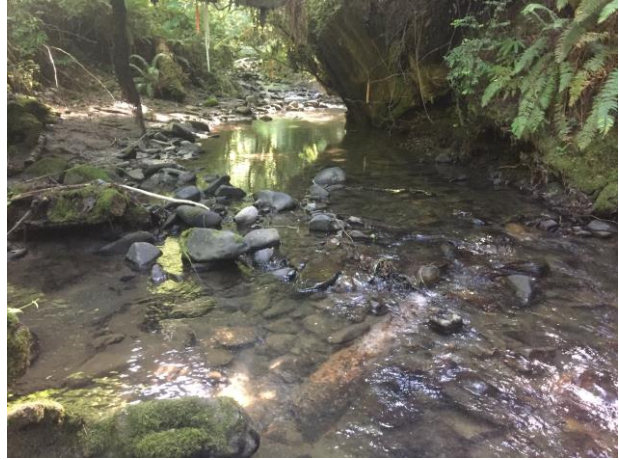
Cummings Creek Station 108

Data for all ATM parameters at site 108 (Figure 13) are summarized in the APFC report card provided in Table 7. The bed surface APFC target was not met at this site in 2019, though the data suggest a coarsening of the substrate across all particle size classes (Figure 16). Pool characteristics suggest a general decline in habitat quality since 2013, though 100% of pools surveyed were either formed by or associated with LWD. The total LWD piece frequency within the surveyed reach fell short of the APFC target by a margin of 4.4 pieces per 100 feet of stream channel, as total LWD pieces decreased 121% since 2016. Water temperature met the target goal for the 17th consecutive year on record, and mid-channel canopy cover met the target for the 4th straight survey year.

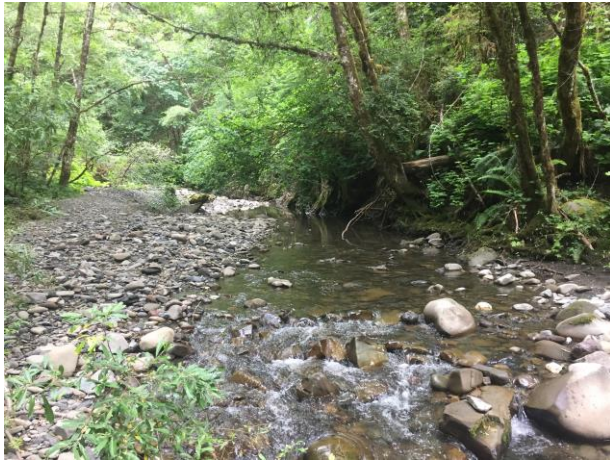
Grizzly Creek Station 111

Data for all ATM parameters at site 111 (Figure 13) are summarized in the APFC report card provided in Table 8. The bed surface APFC target was met in 2019, as the data suggest a coarsening of the substrate across all particle size classes (Figure 18). Pool characteristics remained generally static since 2013, with residual pool depth consistently failing to meet the target criterion. The total LWD piece frequency within the surveyed reach did not meet the APFC target by a margin of 1.2 pieces per 100 feet of stream channel, as total LWD pieces decreased by 78% since 2016. Water temperature failed to meet the target by 0.1 °C while mid-channel canopy cover met the target goal for the 4th consecutive survey year.

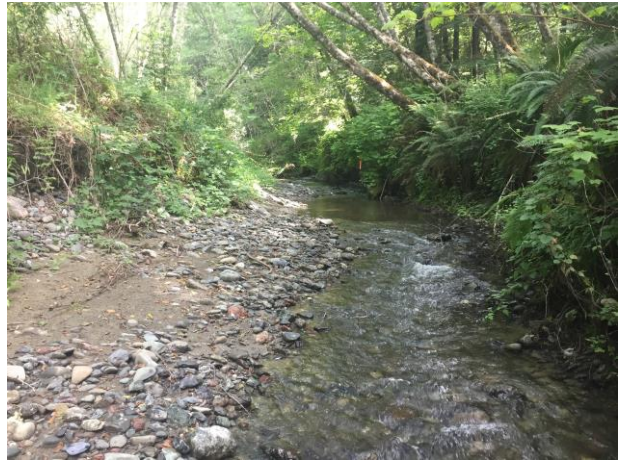
Hely Creek Station 112

Data for all ATM parameters at site 112 (Figure 13) are summarized in the APFC report card provided in Table 9. The bed surface APFC target was met in 2019 for the first time on record, as the data suggest a coarsening of the substrate across all particle size classes (Figure 20). Pool characteristics remained generally static since 2016, with residual pool depth and pool area consistently failing to meet the target criteria. The total LWD piece frequency within the surveyed reach did not meet the APFC target in 2019, as total LWD pieces decreased by 32% since 2016. Water temperature met the target goal for the 16th consecutive year, though mid-channel canopy cover fell short of the target the 2nd straight survey year.

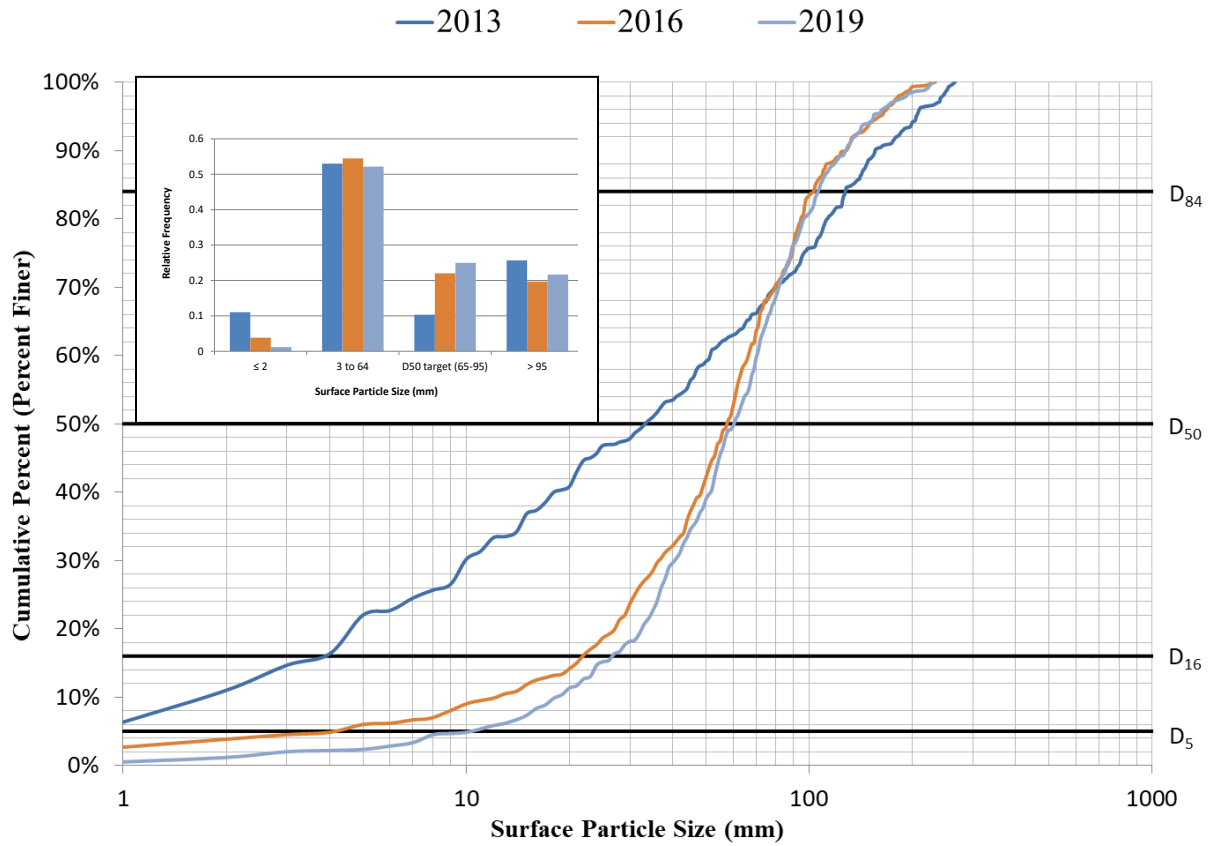
Figure 16. Cumulative frequency plot of the mean surface particle size of three riffles measured within the Cummings Creek ATM 108 monitoring reach (2013-2019)

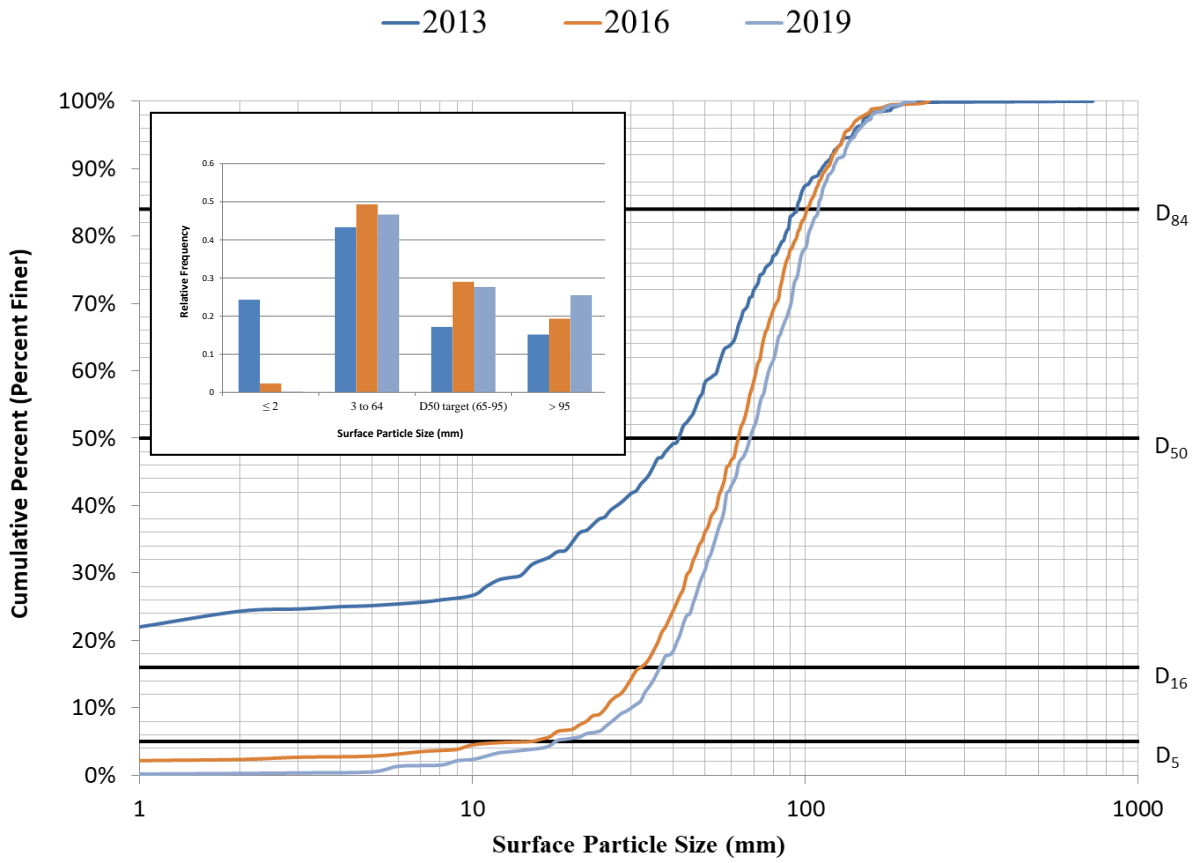
Figure 20. Cumulative frequency plot of the mean surface particle size of three riffles measured within the Hely Creek ATM 112 monitoring reach (2013-2019)

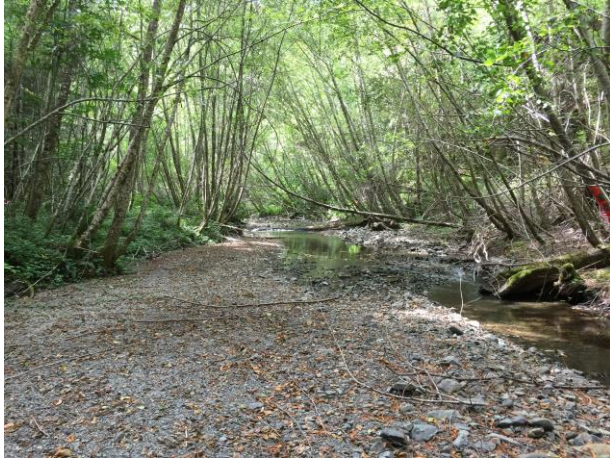
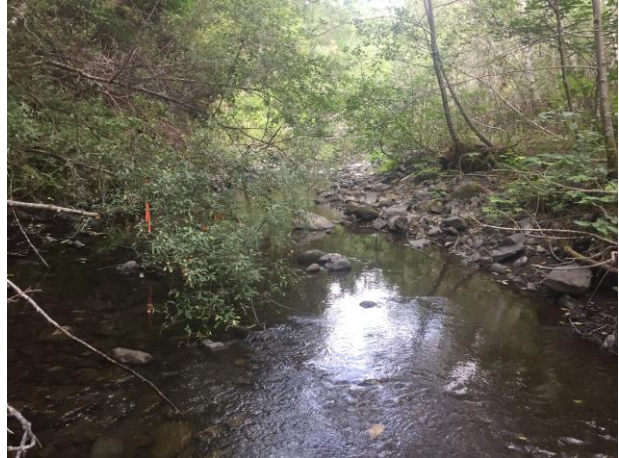
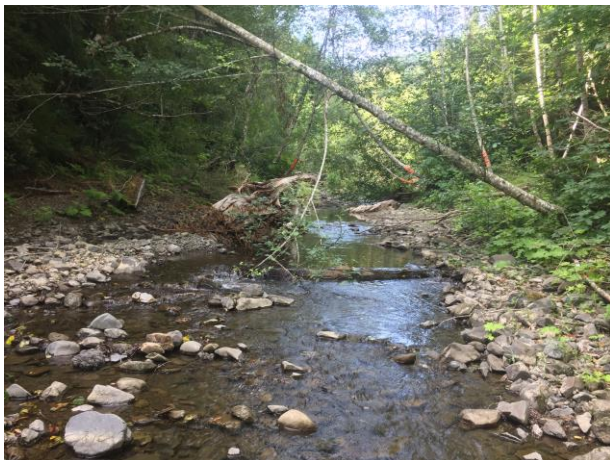
Figure 24. Bear Creek ATM stations within the Lower Eel River WAU

There are eight (8) ATM sites in the Lower Eel WAU, including three in Bear Creek, two in Jordan Creek, and one each in Monument Creek, Shively Creek, and Atwell Creek (Figure 23). Habitat characteristics at the Bear Creek sites are measured annually at the request of the NCRWQCB. Habitats at all other sites are measured every three years. Typical site conditions are shown in Figures 24 and 25.
