**Humboldt
Redwood™**

**Elk River/Salmon Creek
Watershed Analysis Revisited**

June 13, 2014

Purpose: Aquatic Habitat Conservation Plan Monitoring Report

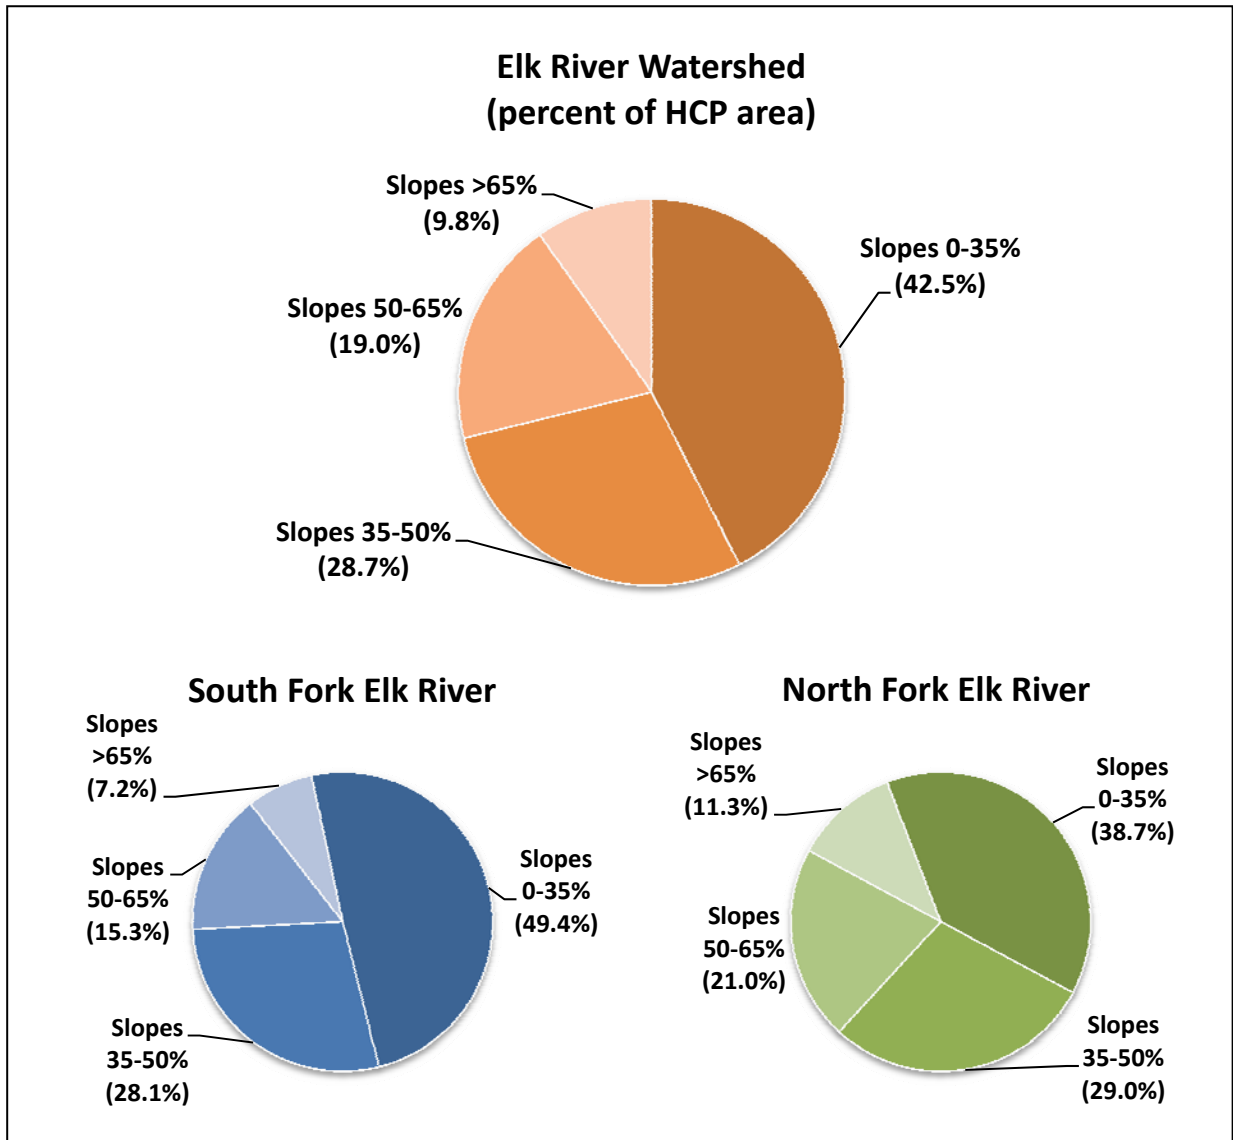
Figure 2-1. Distribution of topography within the HRC Elk River HCP area.

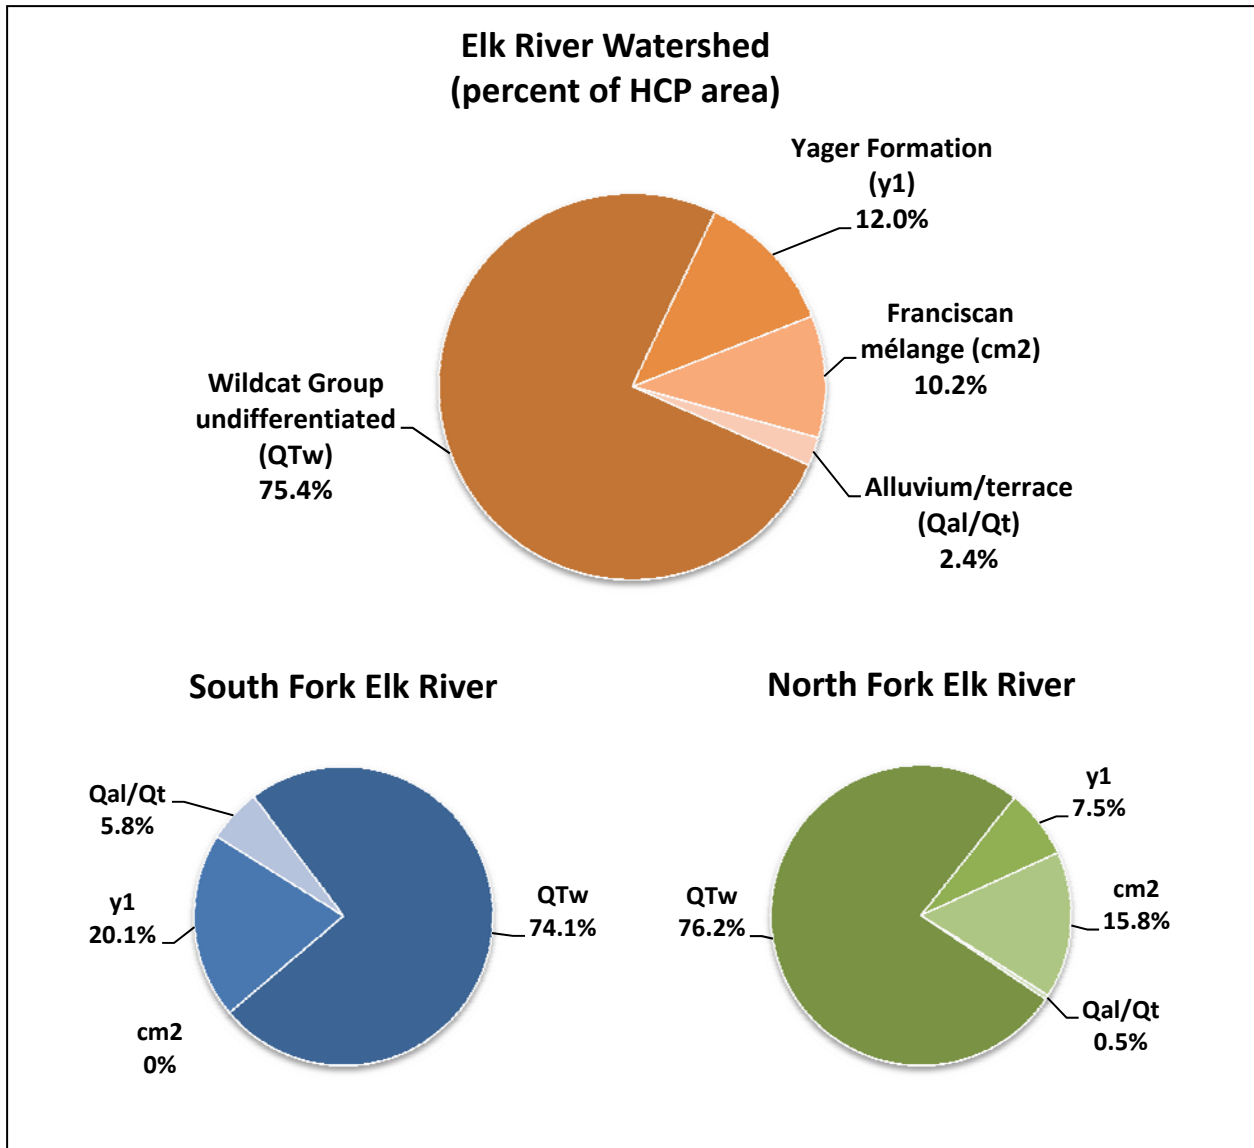
Figure 2-2. Distribution of lithologic units within the HRC ERSC HCP area.

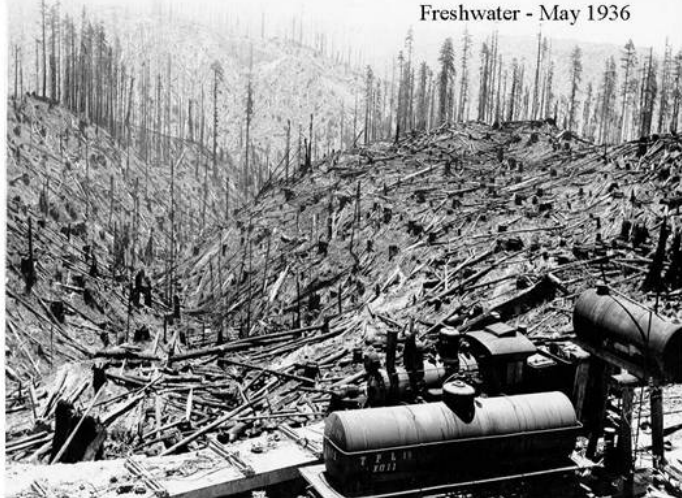
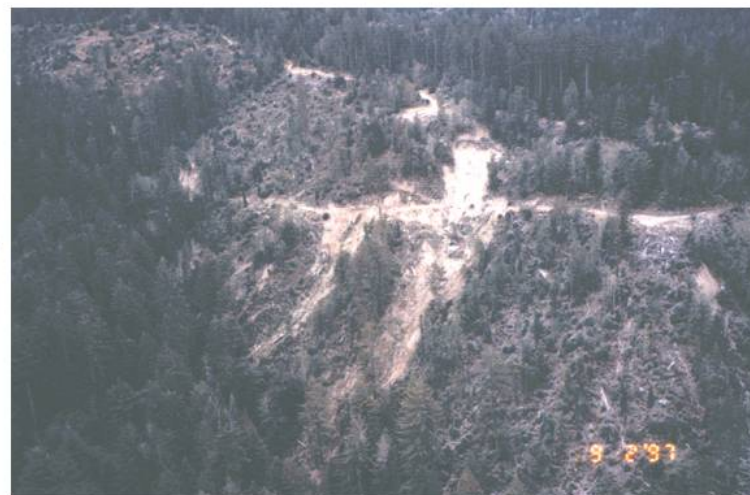
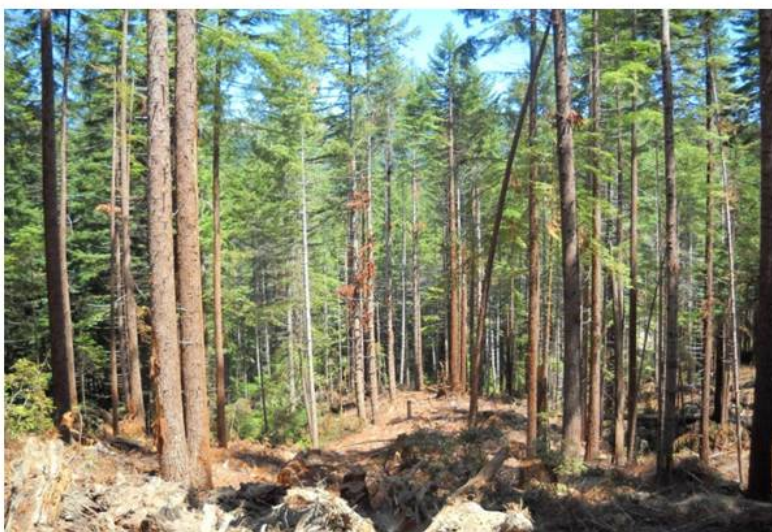
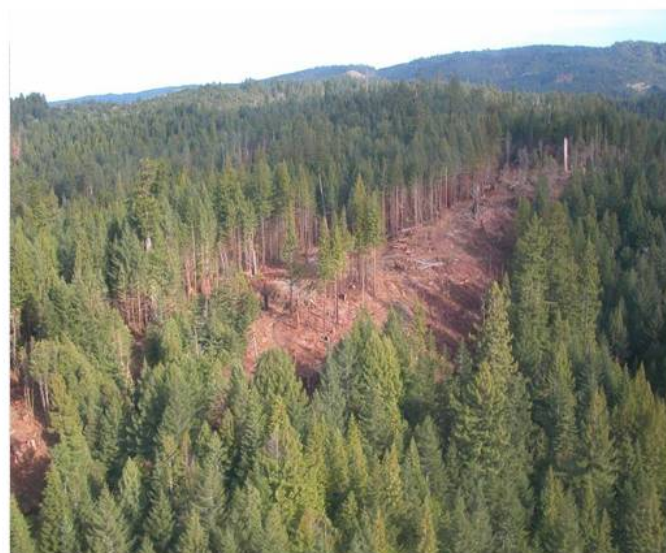
Figure 3-1. Photographs illustrating forest silvicultural practices history in Elk River and Freshwater Creek.

First cycle 1860-1950

PALCO prior to 1999

HRC uneven-age management 2008-current

PALCO 1999-2008

During much of the historical period, high impact activities were conducted without regard to landscape sensitivity to erosion processes or riparian forest integrity. Since 1974, California Forest Practice Rules have guided forest management practices to minimize impacts of activities on water quality and sedimentation. Updates to these rules during the past 40 years have continually improved protections related to road construction and maintenance practices and riparian management as scientific understanding of linkage to aquatic habitat conditions and processes has increased. The HRC (formerly PALCO) HCP has further strengthened conservation measures, guided specifically by studies of environmental conditions found on HCP covered lands. Figure 3-1 provides photographs illustrating typical logging practices during various eras.

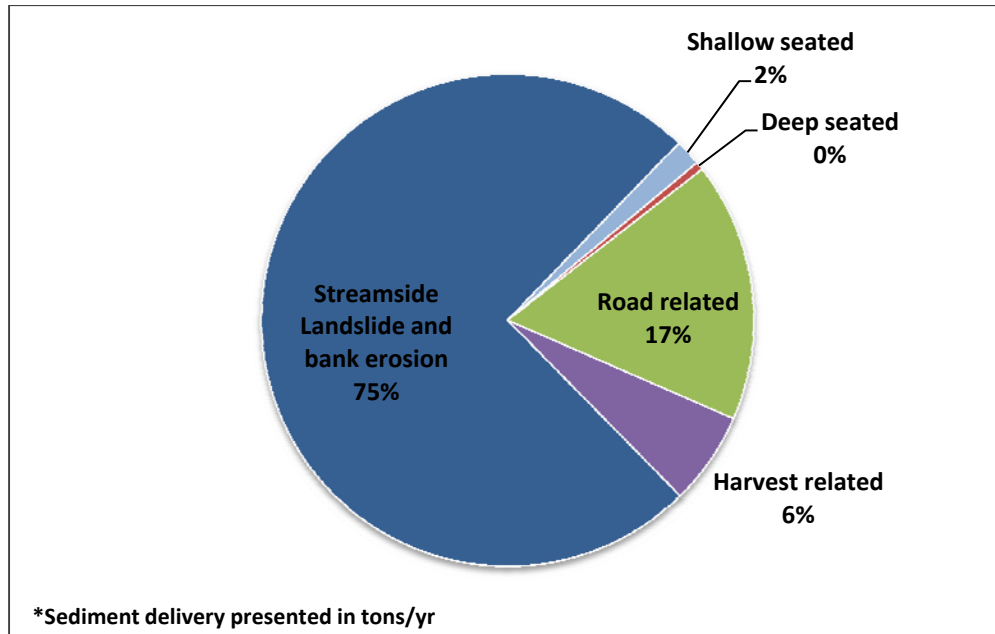
Figure 4-14. Sediment delivery by landslide type, 2001-2011.

Overall, streamside landslide and bank erosion processes currently account for approximately 75 percent of the delivered sediment from landslides in the ERSC WAU (Figure 4-14). We interpret this condition as indicative of a recovering watershed where reduction in upslope management-related sources result in natural streamside processes resuming a greater role in the sediment budget, relative to all sources.

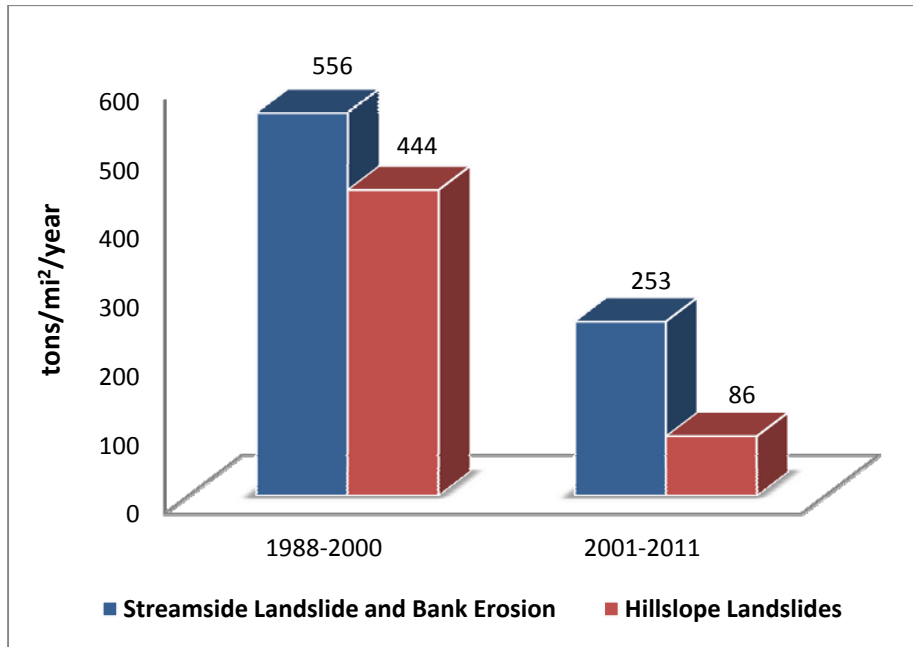
Figure 4-15. ERSC HRC HCP streamside landslide and bank erosion estimated delivery rates compared to hillslope landslides, 1988-2000 vs. 2001-2011.

Streamside landslide and bank erosion processes accounted for the majority of landslide sediment delivery for both decades (Figure 4-15) with a total estimated rate of 556 tons/mi²/year from 1988 to 2000 compared to a much reduced rate of 253 tons/mi²/year during the decade 2001 to 2011.

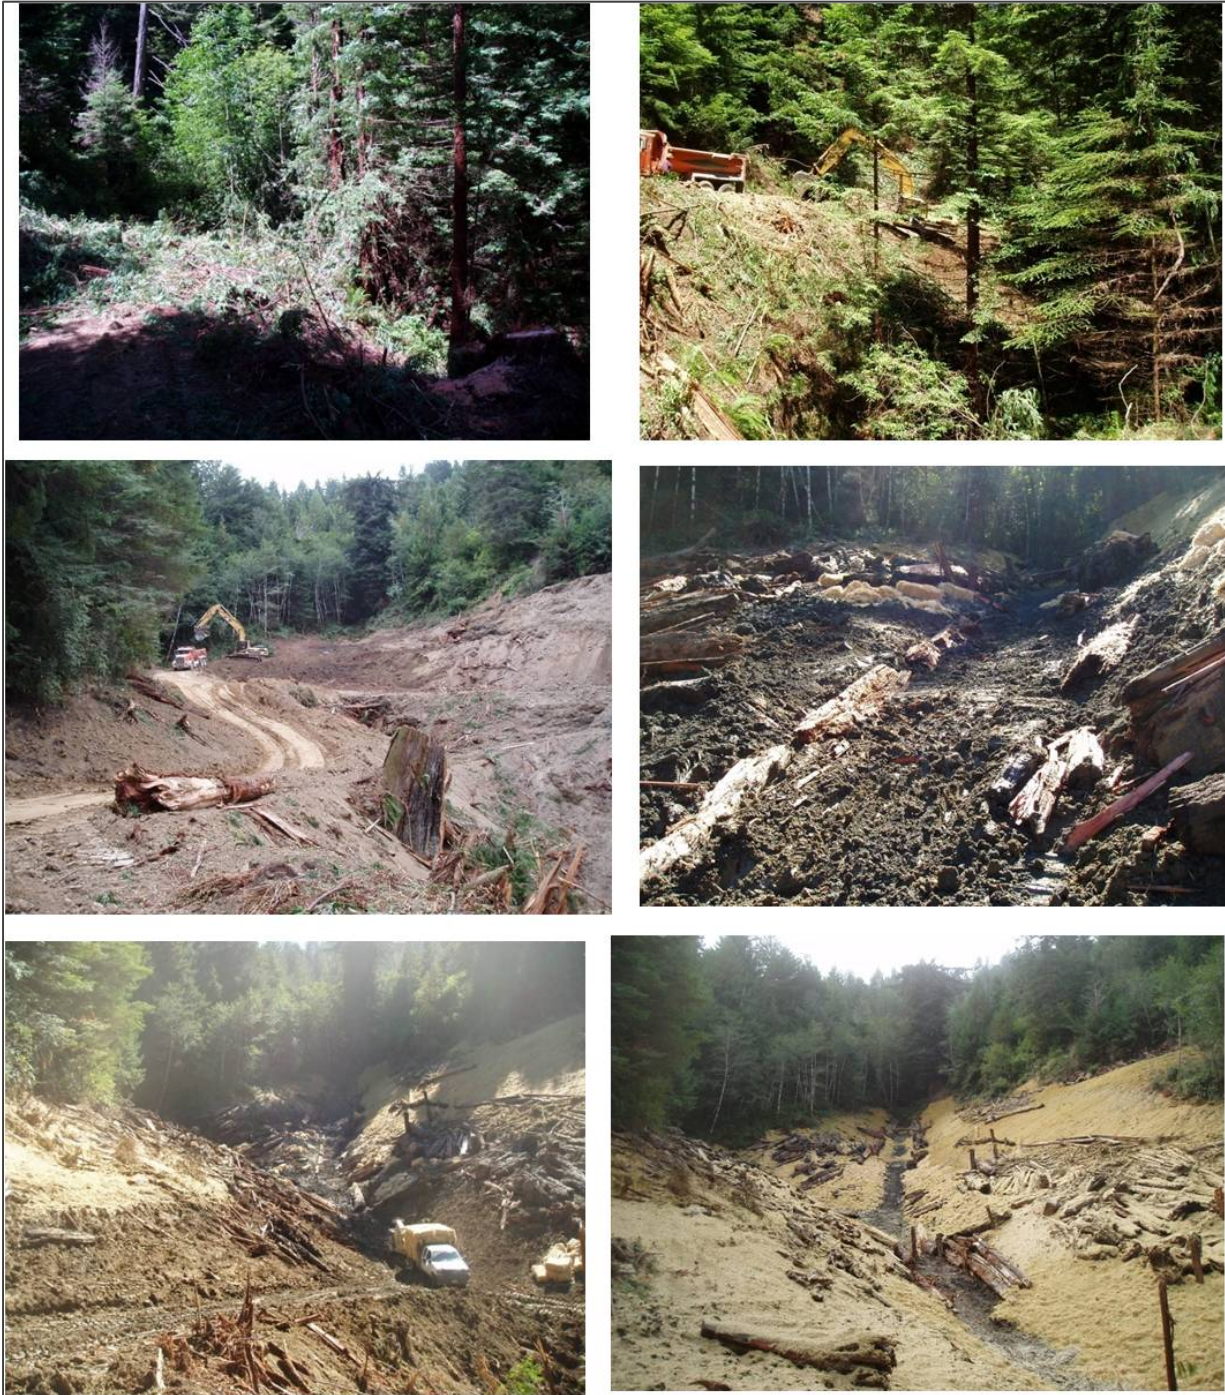
Figure 4-22. Time sequenced photographs of the excavation of the “Big Dig” site.

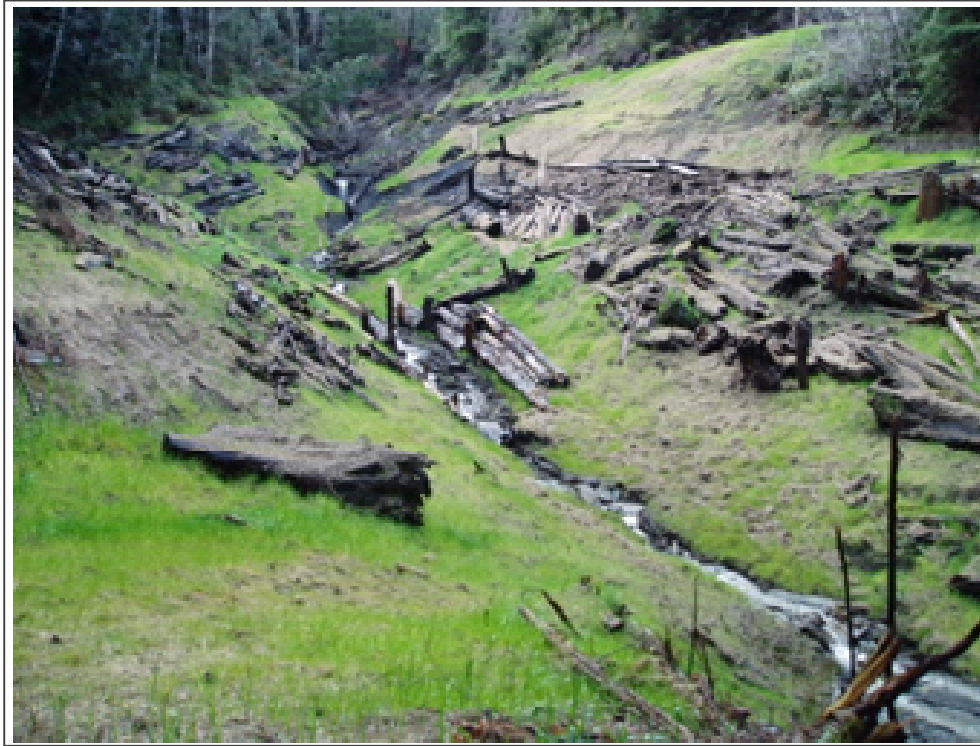
Figure 4-23. Photograph of Big Dig site in North Fork Elk the summer following site deconstruction.

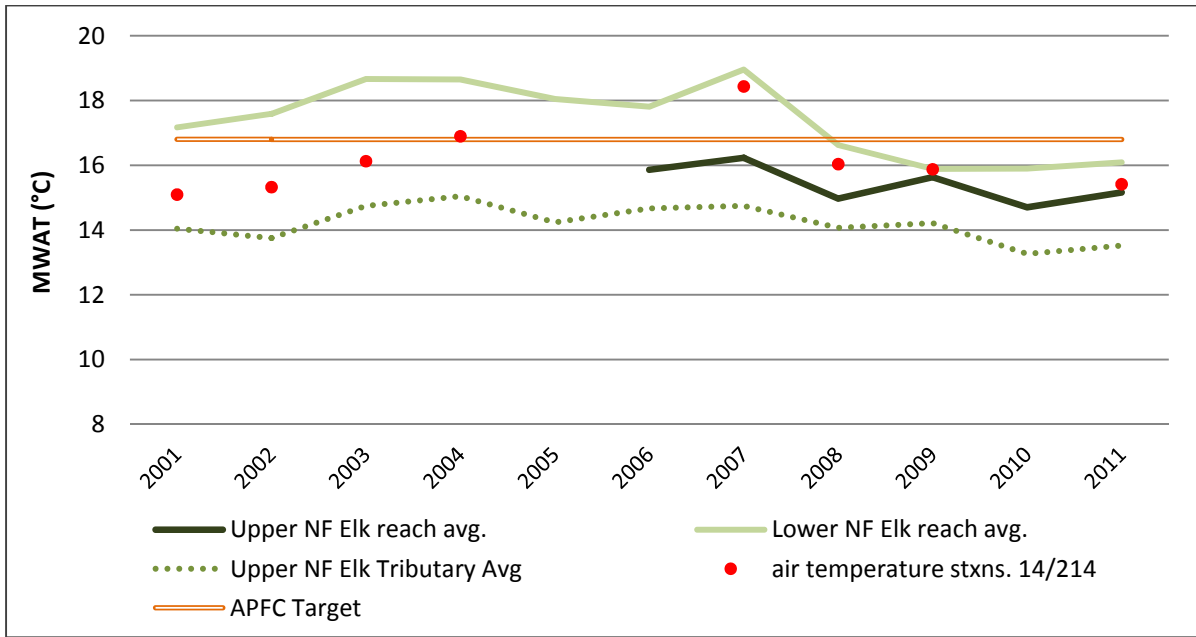
Figure 5-2. North Fork Elk River HRC ATM water temperature records 2001-2011.

MWAT values have been below 16.8°C, and therefore meeting the target, at all stations since 2008. While a fairly consistent trend towards cooler temperatures has been observed, there is also some variation throughout the watershed (Figure 5-2 and Figure 5-3). These cool temperatures appear to correlate with an over-stream mid-channel canopy cover that has either remained fairly constant or has been trending toward an increased canopy cover. This can be seen in the SF Elk River (>90% canopy) and in the Upper North Fork where canopy cover most recently ranged from 80 – 90 percent (Figure 5-4). Both Upper and Lower North Fork regions exhibited a temporary reduction in canopy closure possibly due to peak flow-associated scouring events from the winter of 2006 (HY 2007). Water temperatures in North Fork and mainstem Elk River also were elevated in 2007 likely from a combination of temporarily reduced upstream canopy and high air temperature. Timber harvest has little to no effect on mid-channel canopy closure as no harvest occurs within 50 feet of the stream bank, or along the lower North Fork Elk within 150 feet.

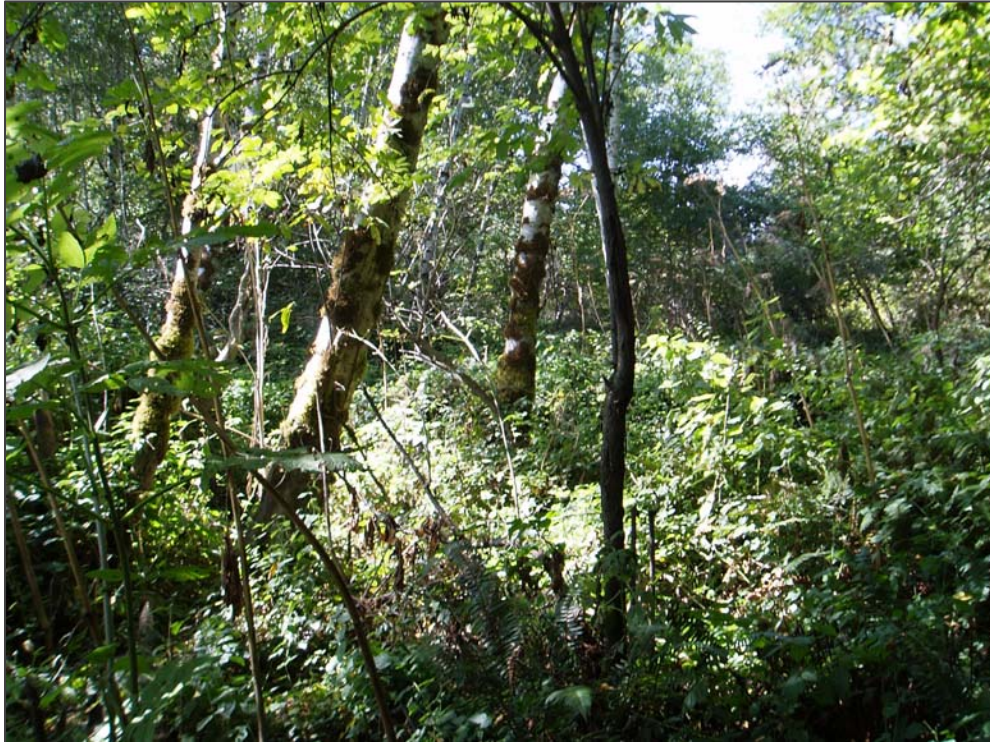
Figure 5-5. Example of Lower North Fork Elk River Riparian Enhancement Area, pre-treatment, 2007.

Several suitable sites (i.e. immediately inside the property-line, Bible Camp, and Boy Scout Camp) were located within the target area and prepared for planting by masticating or lopping and scattering small hardwood trees and brush. Conifer seedlings including redwood and Sitka spruce were subsequently planted throughout the sites. All in all, several acres were planted (circa 2007-2010) and survival of planted trees to date HRC estimates at greater than 70 percent. Figure 5-5, Figure 5-6, and Figure 5-7 illustrate typical sites before treatment, immediately after treatment, and in 2014, respectively.

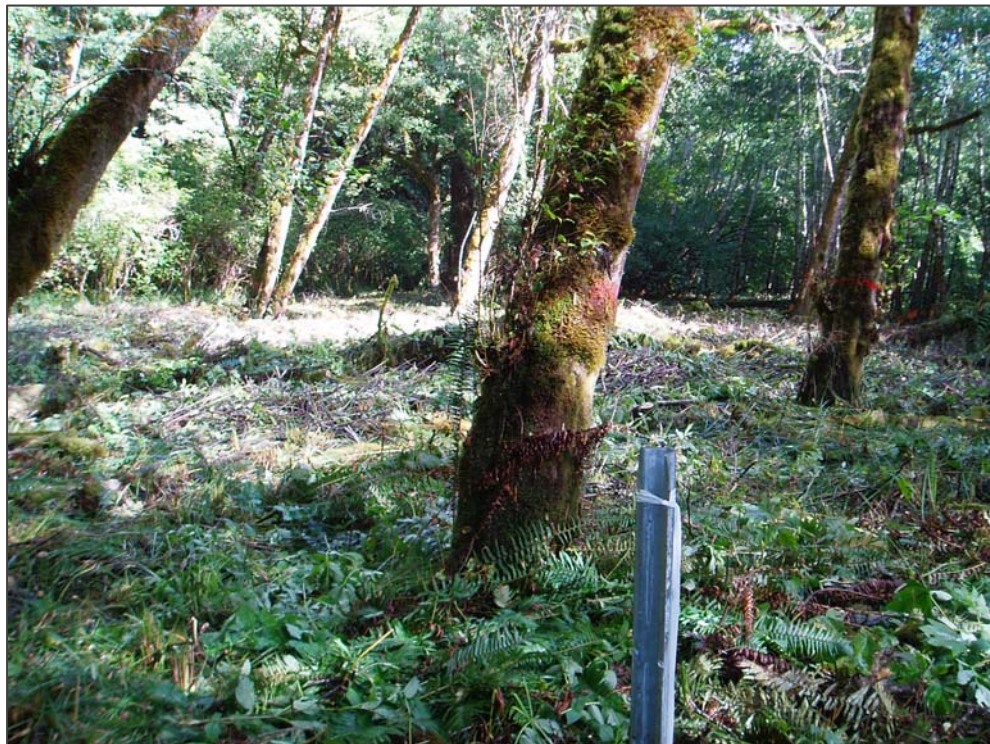
Figure 5-6. Lower North Fork Elk River Riparian Enhancement Area, post-treatment, 2007.

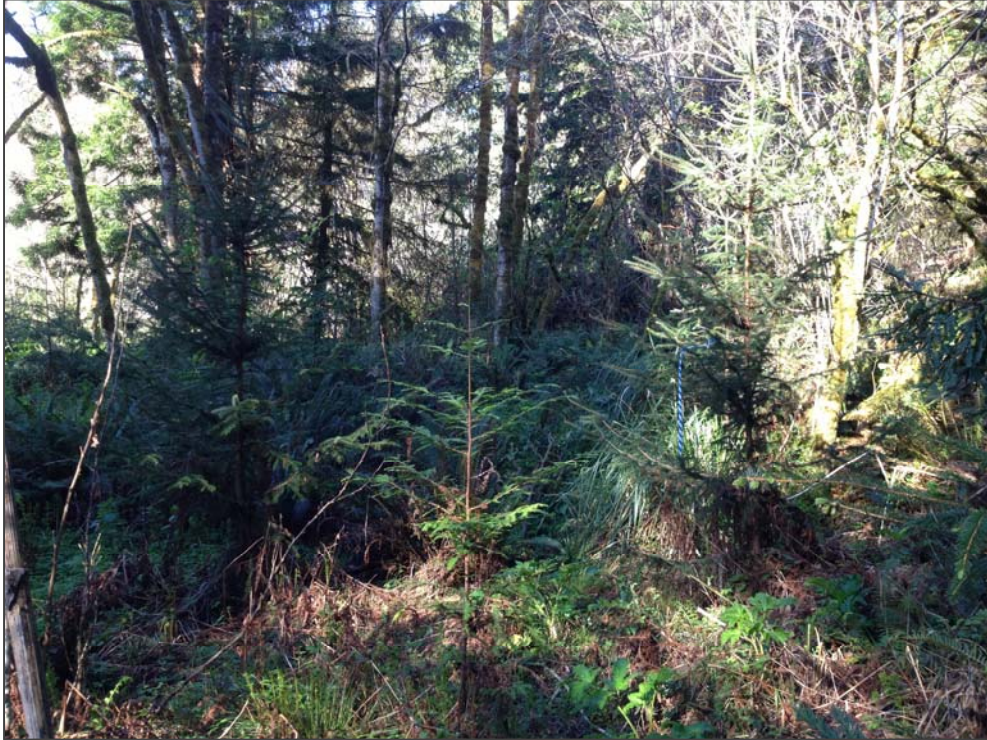
Figure 5-7. Example of Lower North Fork Elk River Riparian Enhancement Area, seven year old planted redwood and Sitka spruce, 2014.

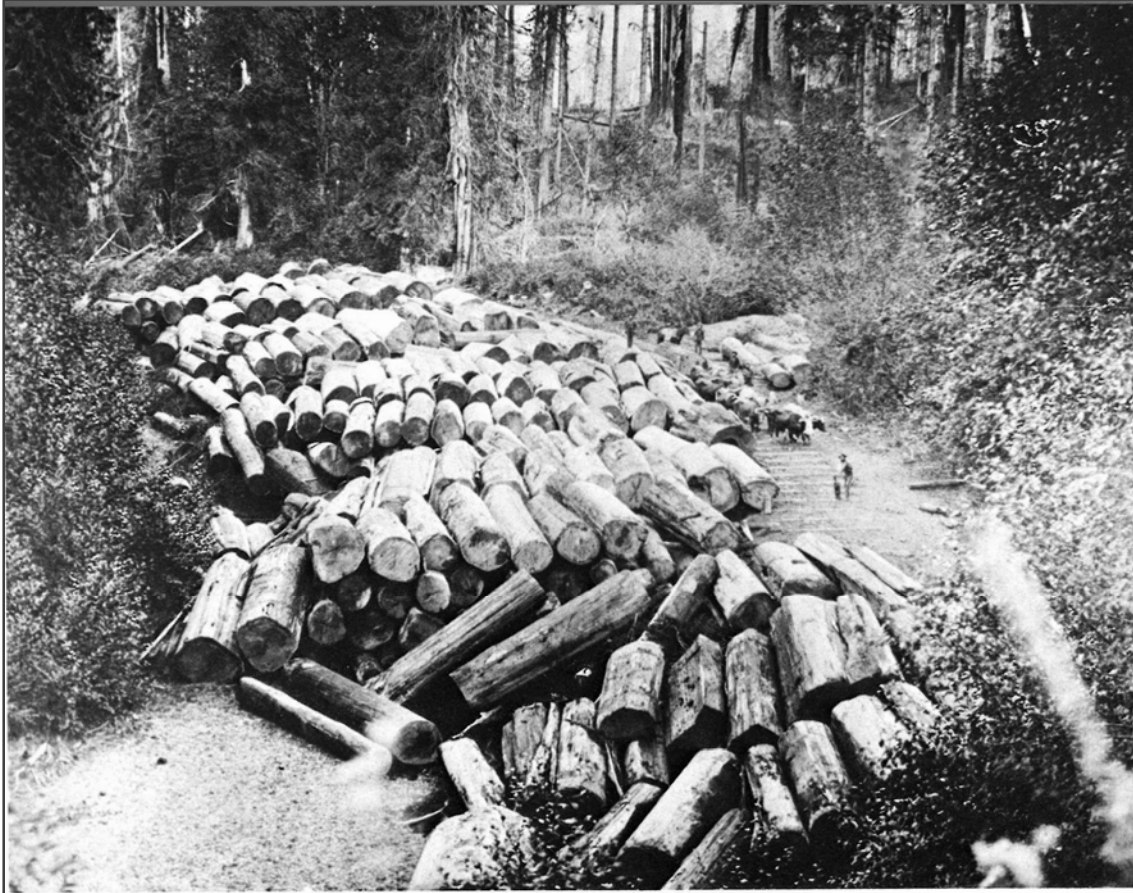
Figure 6-1. Logs stacked in Elk River in 1892, waiting for a winter freshet to carry them downstream. Seth Buck Collection.

Historic timber operations directly affected channel conditions in several ways including use of smaller channels as skid roads for log transport and the larger mainstem channels as the original means by which to transport logs to Humboldt Bay for milling (Figure 6-1). The Humboldt Times newspaper reported routine use of man-made dams throughout the 1870s to create early winter season floods ("booms") by which loggers drove millions of board feet of old growth logs down the river to the bay. *Falk's Claim*, authored by John Humboldt Gates (1983), describes the process:

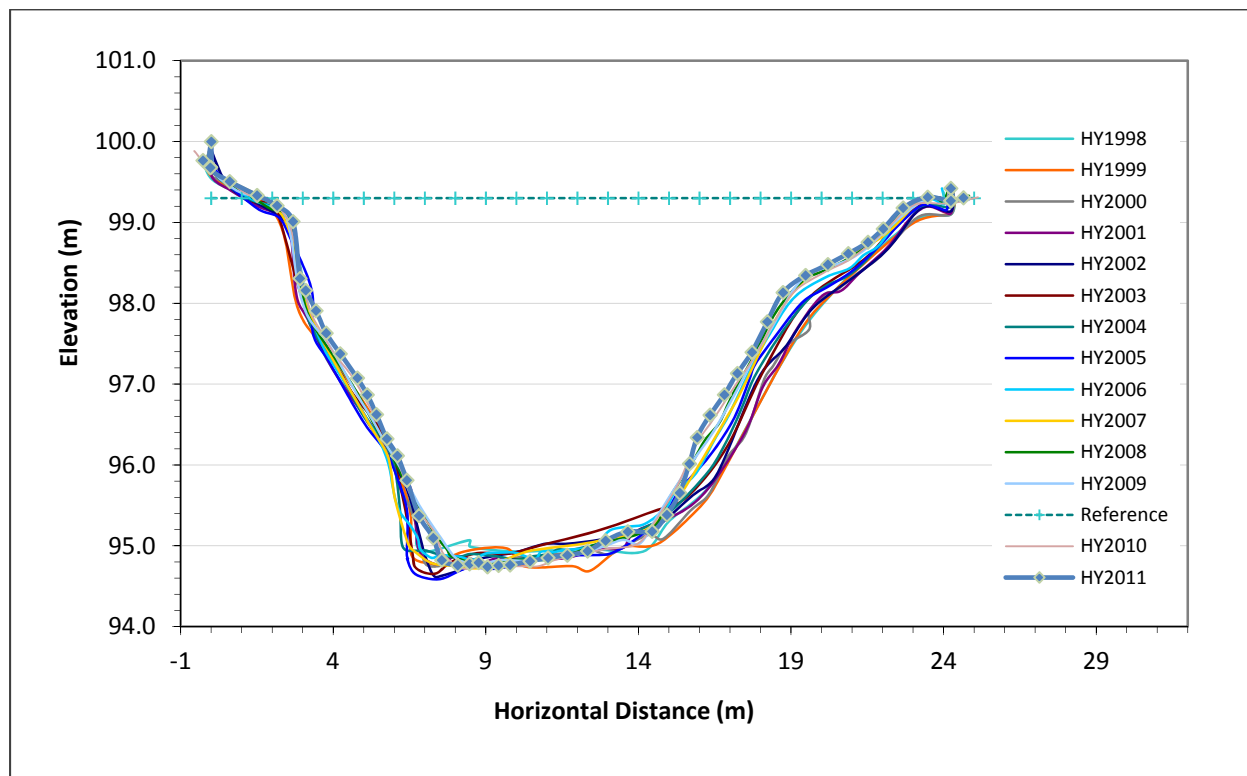
Figure 6-2. Cross-section at HRC ATM 166 exhibiting aggradation along mainstem Elk River.

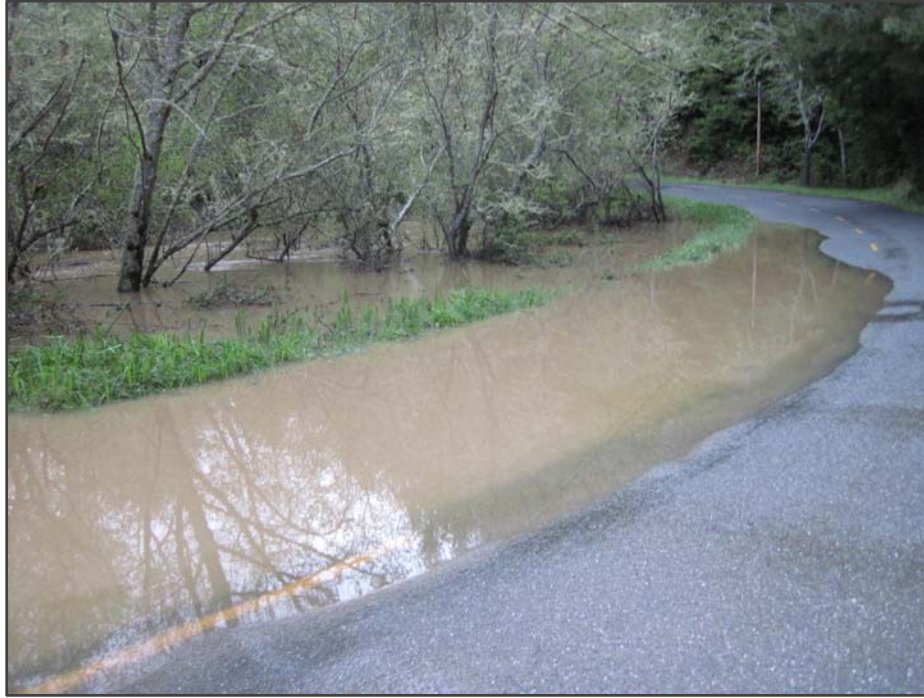
Figure 6-3. Mainstem Elk River at Dead Woman's Curve during a flood event, 2012.

While historical accounts identify flooding as a natural and long standing occurrence in the Elk River valley, flood frequency has reportedly increased in recent years as channel conveyance has been reduced due to ongoing sedimentation. Flooding typically occurs first, and most often, at the location known locally as Dead Women's Curve (DWC). This approximate 200-foot section of road parallels the North Fork Elk River within a few feet of the main channel, and dips toward the river as it flows through a sharp meander bend (Figure 6-3). DWC has flooded approximately 50 times in the last ten years with the number of measured events per year ranging from 0 to 8 (Table 6-2). Flooding events are defined as an event where measurable water is present at the lowest part of the road (Figure 6-3). The duration of events with water on the road surface ranges from less than an hour to as long as three days. *Road flooding in excess of 0.75 meters on the road surface is estimated to make the road impassable to passenger car traffic (personnel observation, D. Manthorne). It is important to note that the frequency and duration of events causing the road to be impassable is substantially less than the frequency and duration of all recorded "flooding" events.* For example, in HY2012 four events created impassable road conditions while the road remained passable during the other four events, based on the 0.75 meter threshold. Although not all flooding events make this section of the Elk River Road impassable, this episodic flooding is a nuisance to residents and a safety concern.

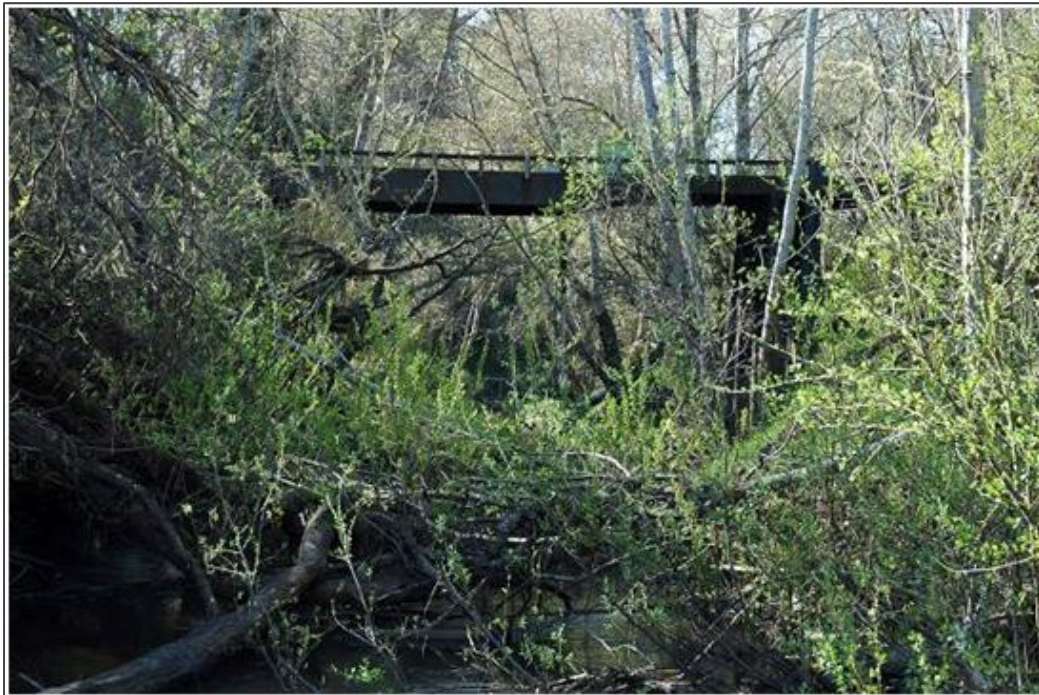
Figure 6-4. Mainstem Elk River vegetation at HTM 509.

Several factors contribute to localized increased flood frequency in the lower Elk River valley. Increased channel roughness in the form of abundant bank vegetation and woody debris accumulations reduce stream flow velocity and entrap sediments (Figure 6-4). As a result of increasing roughness combined with a general lack of stream channel gradient ($<0.2\%$), velocities, even at peak flows, are generally insufficient to generate any significant channel scour. Reduced velocities limit sediment transport capacity and consequently result in deposition in the reaches of greatest channel roughness. This deposition further impinges on the channel over time and provides a fertile environment for additional vegetative growth, consequently further increasing roughness. Changes on the extended flood plain, further back from the channel itself, have occurred over the last 100 years as areas that were once open and grass-dominated are now covered by shrubs, willows, and conifers. This increasing out-of-channel vegetative roughness affects stream flow velocities and flood plain carrying capacity, resulting in flows being pushed further out from the channel than would otherwise occur if the flood plains were less vegetated.

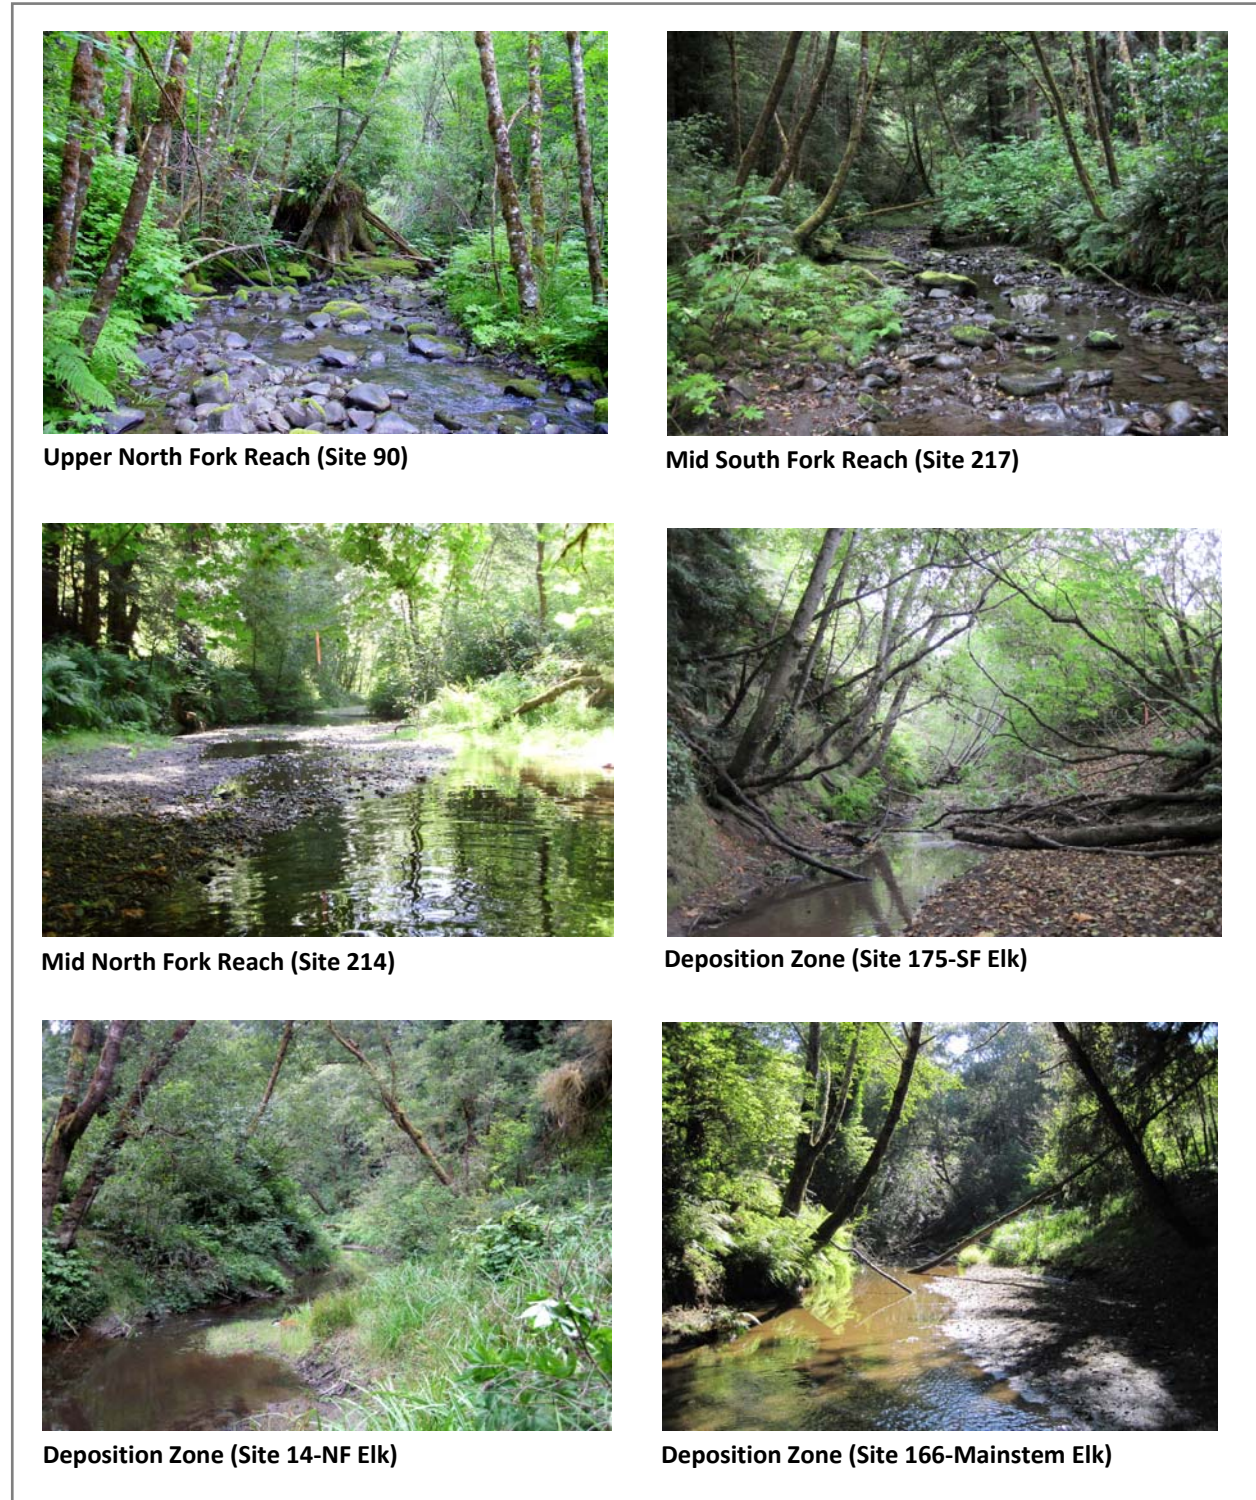
Figure 7-1. Photographs of HRC ATM monitoring sites representative of regions.

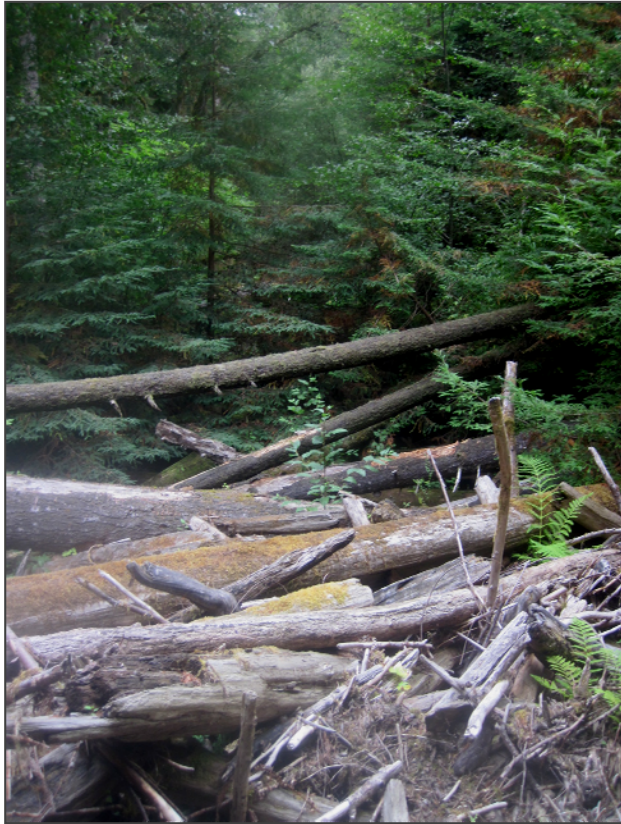
Figure 7-13. Migrational fish barrier on SF Elk River approximately 1/2 mile downstream of confluence with Corrigan Creek.

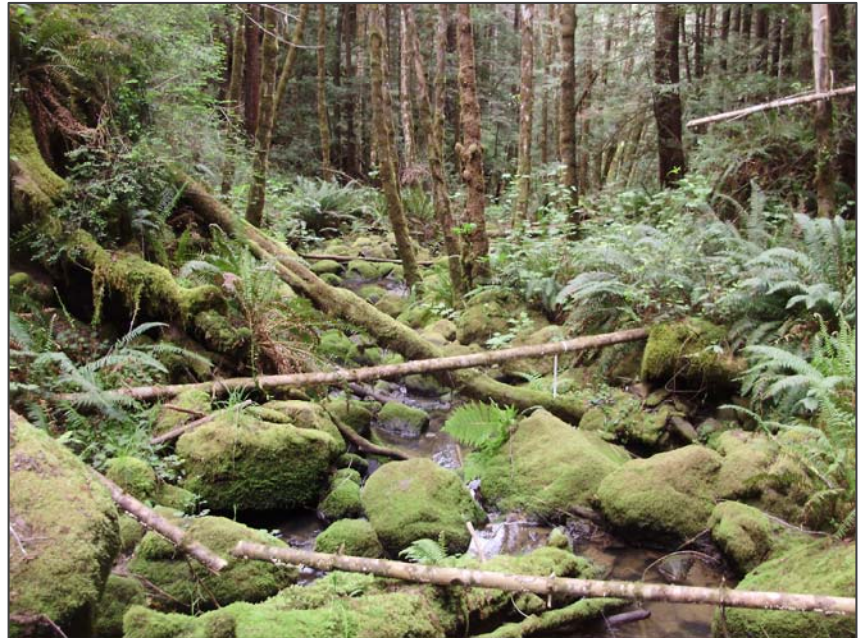
Figure 9-1. Corrigan Creek, immediately upstream of Class I/II transition.

Our second recommendation pertains to the Corrigan Creek LWD Transport Zone prescription (§6.3.4.1.3 bullet #4). As stated previously in section 5.2.3, no harvest has occurred within the Corrigan Creek Class II LWD Transport Zone (RMZ) since its establishment in 2005. Recent field review of this stretch of Corrigan Creek has confirmed the location of the Class I – II break as mapped but also found channel geomorphology above this break in classification *not to be conducive* to large wood transport due to insufficient channel width (\approx five feet), and the presence of a boulder substrate further limiting transport capacity. There is no physical evidence to suggest that this Class II watercourse performs similar to a Class I watercourse in terms of downstream large wood transport and thus the purpose of the special prescription is moot. In addition we note the logic behind the current special prescription appears flawed, as the previously noted current scientific finding indicates recruitment seldom occurs from beyond 50 feet of the watercourse transition line, let alone 100 feet. The concept of increasing the Outer Band to 150 feet for the purpose of increasing recruitment is not supported by current science. For these reasons, HRC recommends discontinuing the prescription specific to this zone and instead applying the standard ERSC Class II protection measures. These proposed prescription changes based on watershed analysis are provided in Appendix 11.
