Mattole River Watershed Analysis
Humboldt Redwood Company
Humboldt County, California

Road-Related & Non-Road-Related Landslides 1988 - 2003
Plate 7

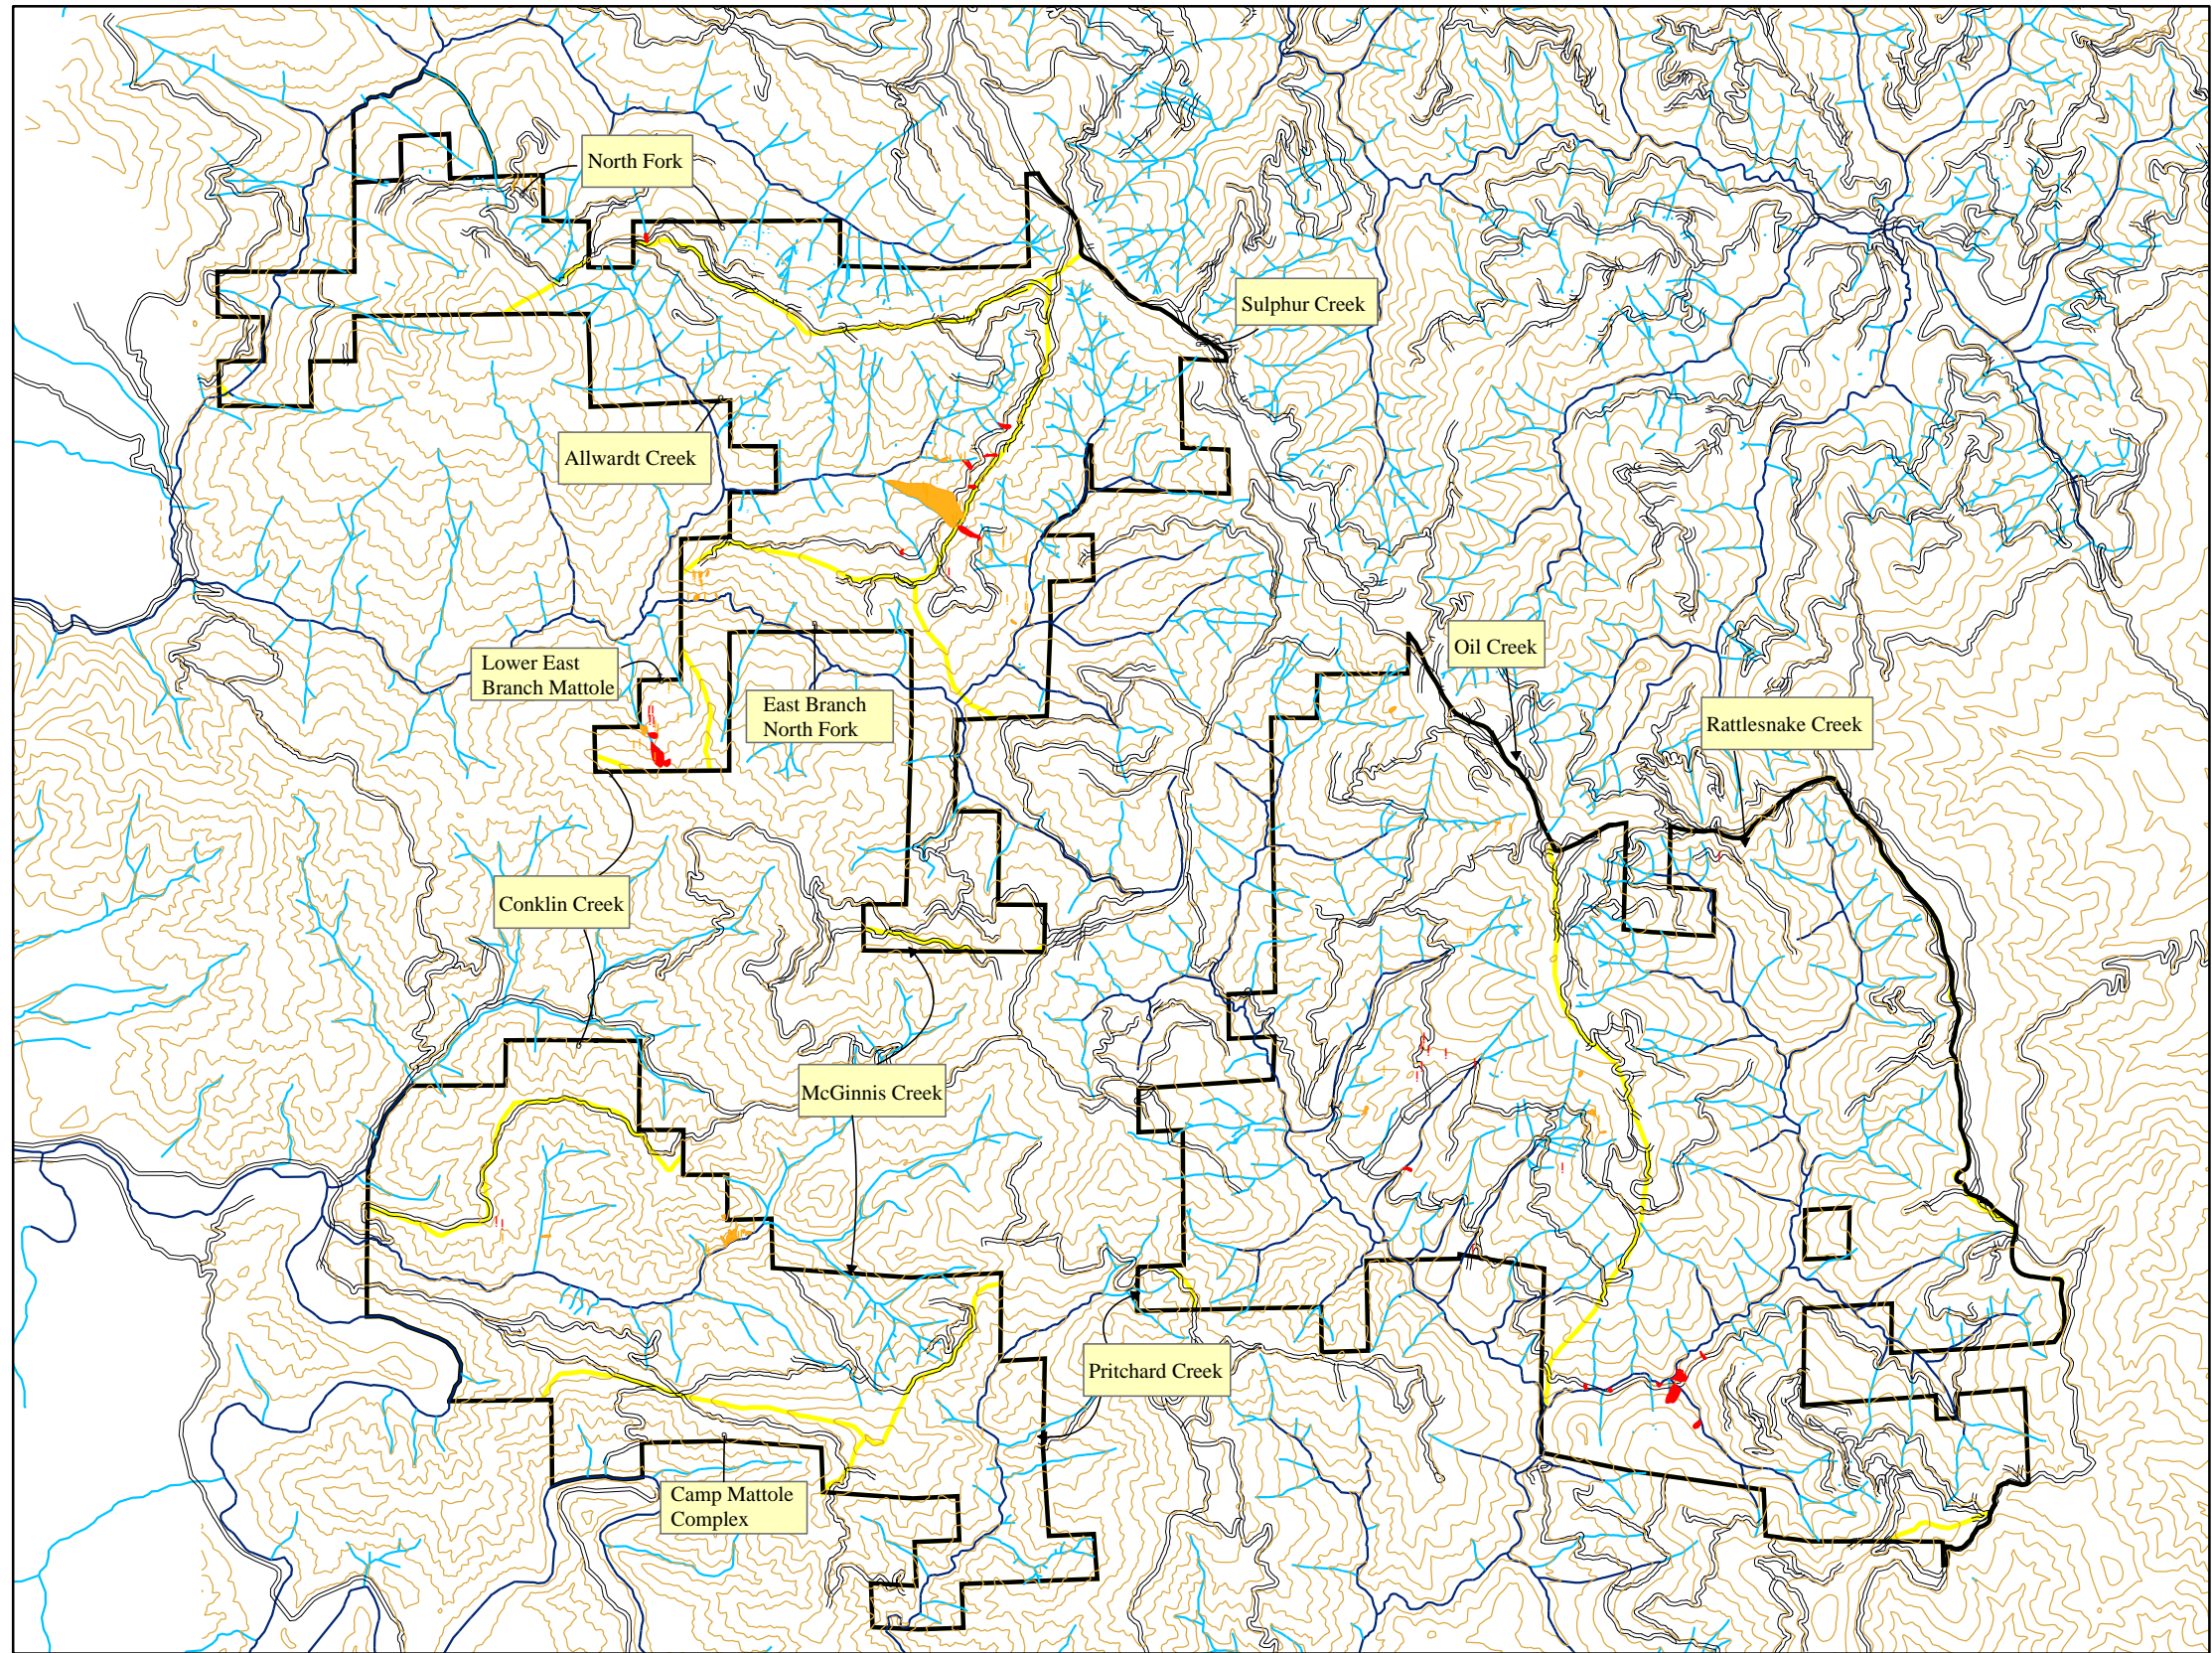
- Management, road-related landslides
- Management, road-related landslides too small to delineate at this scale
- Management, non-road-related landslides
- Management, non-road-related landslides too small to delineate at this scale
- Watershed / Property Boundary
- Subbasin Boundary
- Road
- Class I Stream
- Class II Stream

Contour Interval = 200 Feet
