Mattole River Watershed Analysis  
Humboldt Redwood Company  
Humboldt County, California

Managed, Legacy, and Background Landslides, 1988 - 2003  
Plate 6

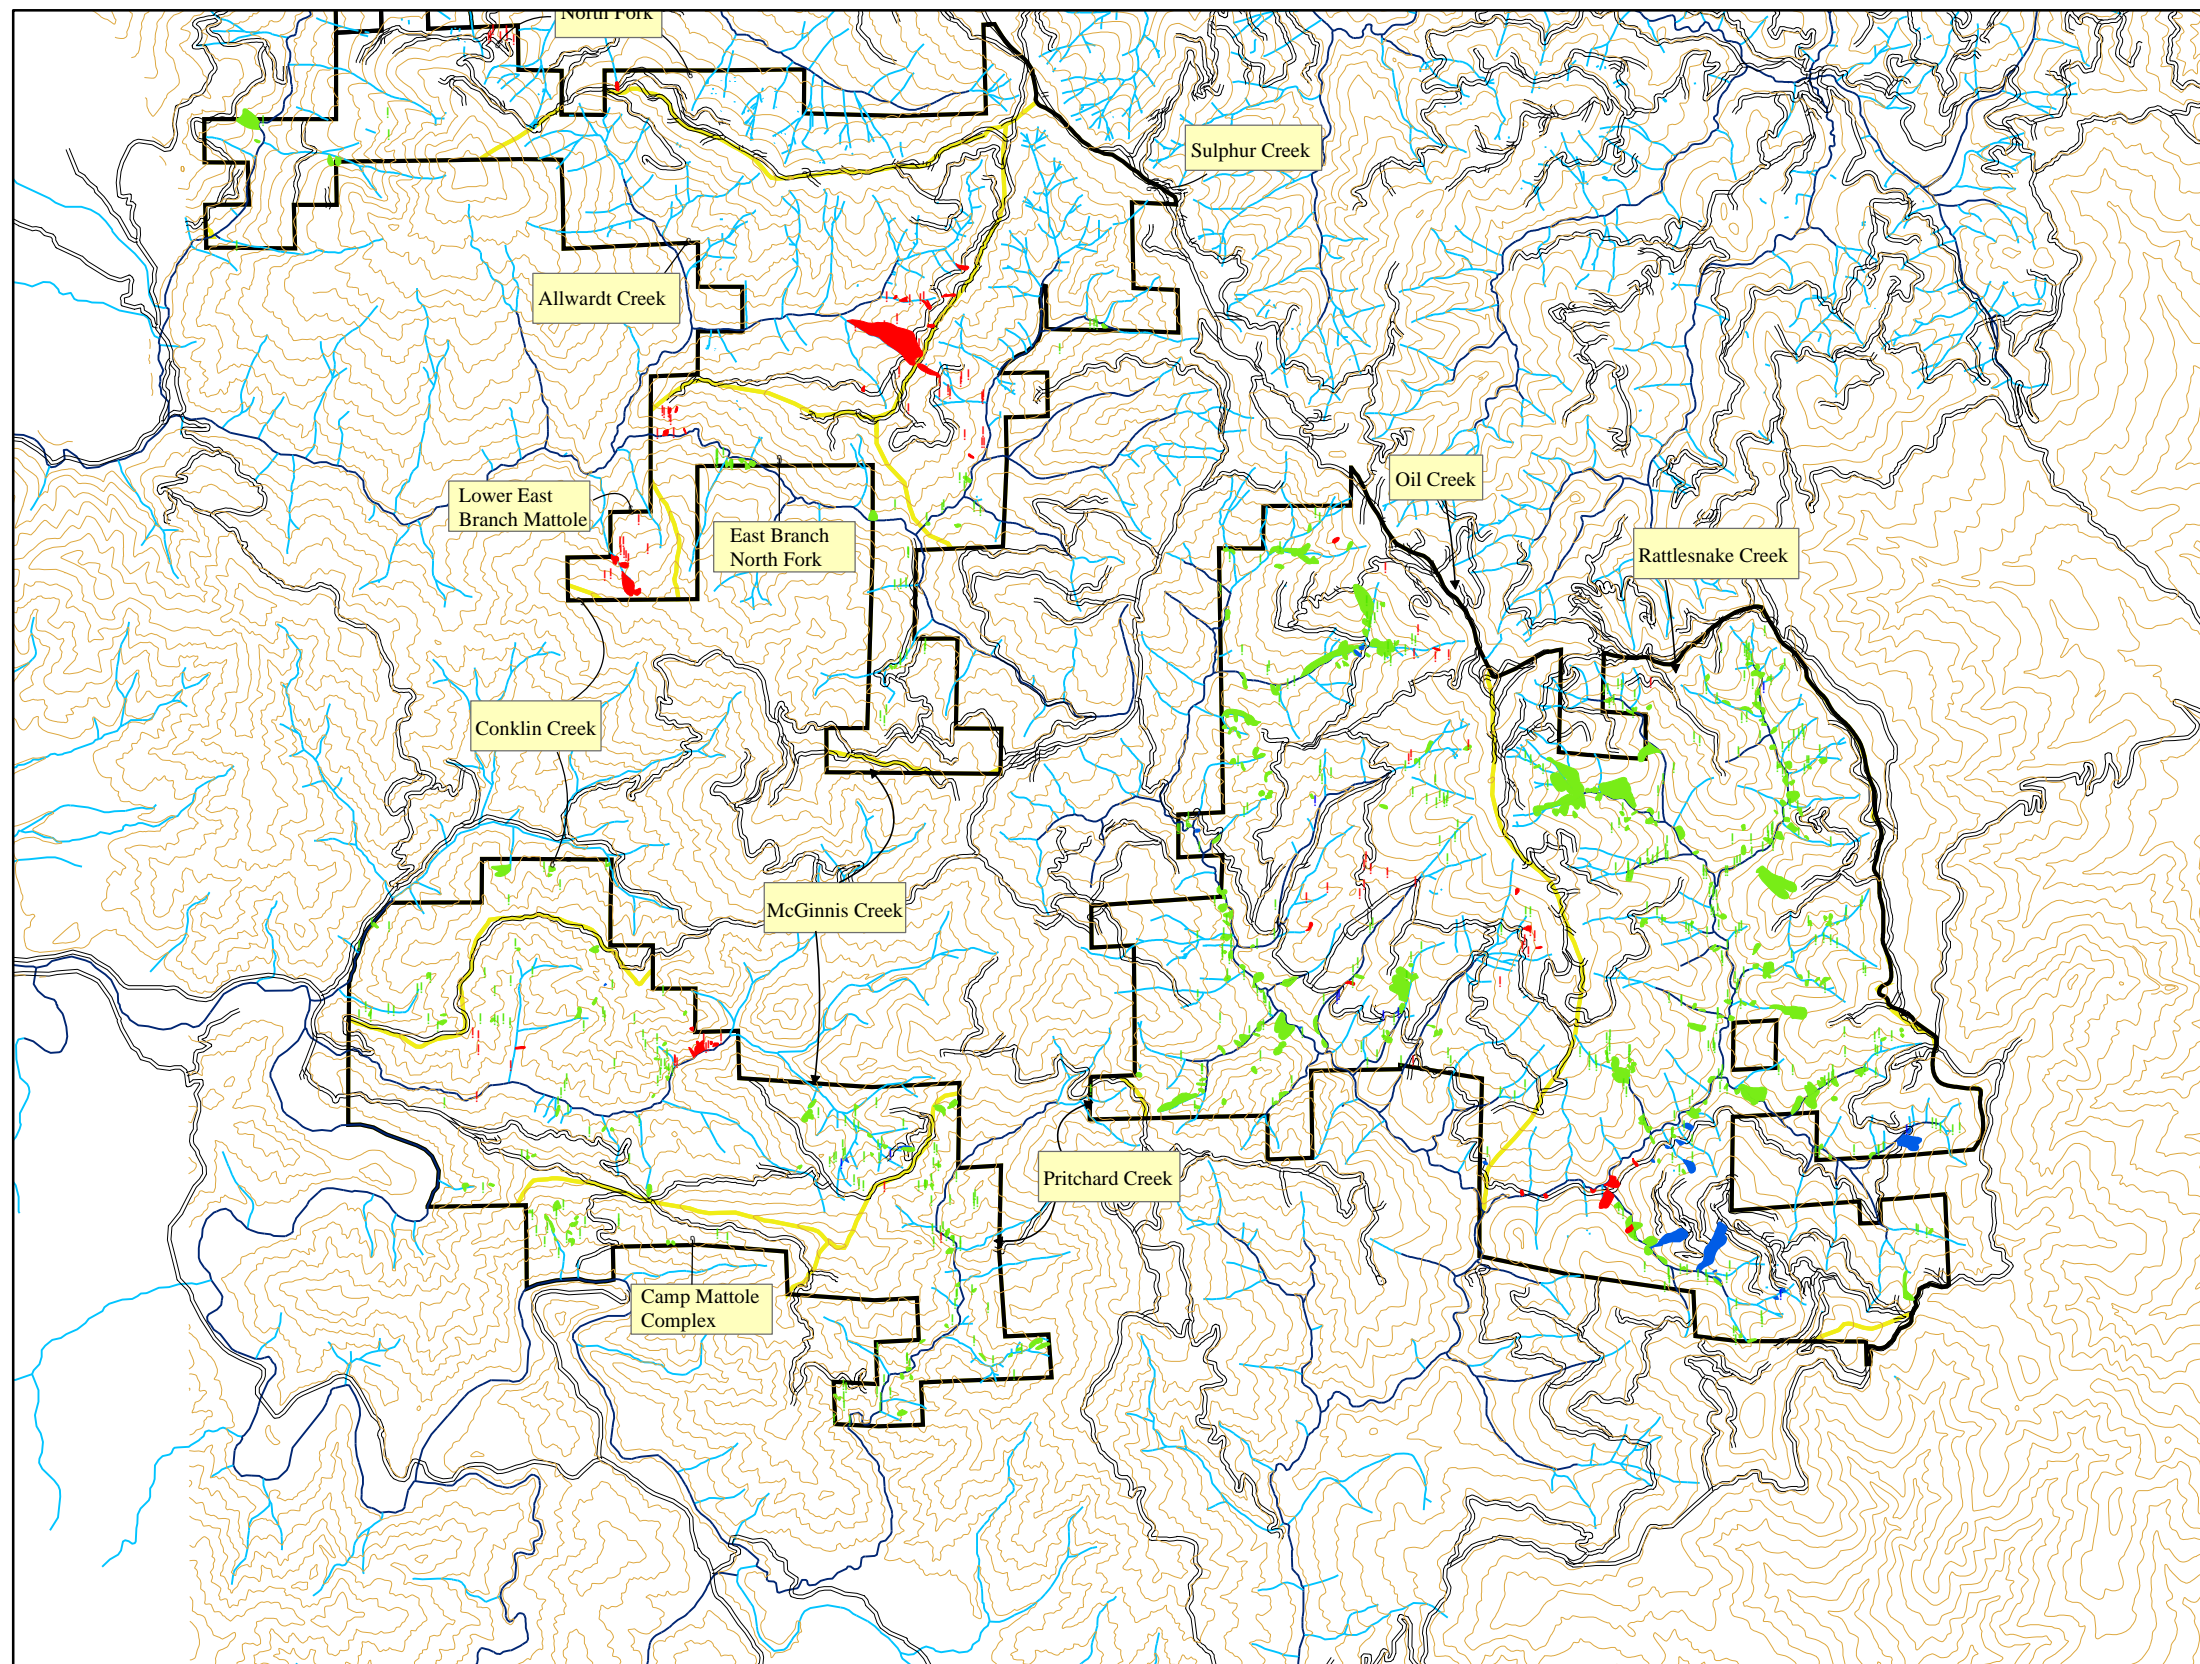
NOTE: Only active landslides in previously managed areas are shown. "Natural" landslides in unmanaged areas are not shown.
