SECTION D RIPARIAN FUNCTION

INTRODUCTION

Mendocino Redwood Company conducted an assessment of riparian function in the Greenwood Watershed Analysis Unit (WAU) during the summer of 2003. This assessment is divided into two groups: 1) the potential of the riparian stand to recruit large woody debris (LWD) and current demand of LWD in stream channels and 2) a canopy closure and stream temperature assessment. The LWD potential assessment evaluates short-term (the next 2-3 decades) LWD recruitment. It shows the current condition of the riparian stands for generating LWD for stream habitat or stream channel stability. Field observations of current LWD levels in the stream channels and the riparian stand's ability to recruit LWD are presented in relation to channel sensitivity to LWD in order to determine current in-stream needs. The canopy closure and stream temperature assessment presents current canopy closure conditions and results of stream temperature monitoring for the Greenwood WAU. The goal of these evaluations is to provide baseline information on the current riparian stand functions in the Greenwood WAU.

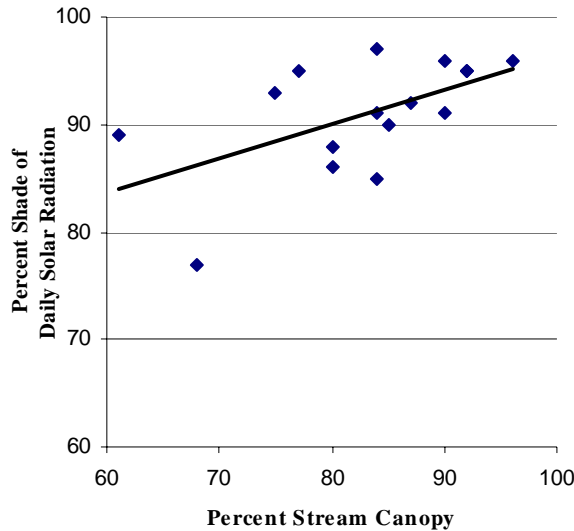
Figure 1. Percent Solar Radiation Shade versus Percent Stream Canopy for Sites in the Greenwood WAU, 2003.

Along each of the sampled stream segments a representative cross section of a riffle of the segment is measured during the stream channel assessment. At this cross section location one reading of the percent of solar radiation the stream is exposed to in August (a high temperature summer month) is measured using a solar pathfinder. In addition to the percent of solar radiation, the percent of topography shading solar radiation and the canopy closure over the stream are observed at the same location.

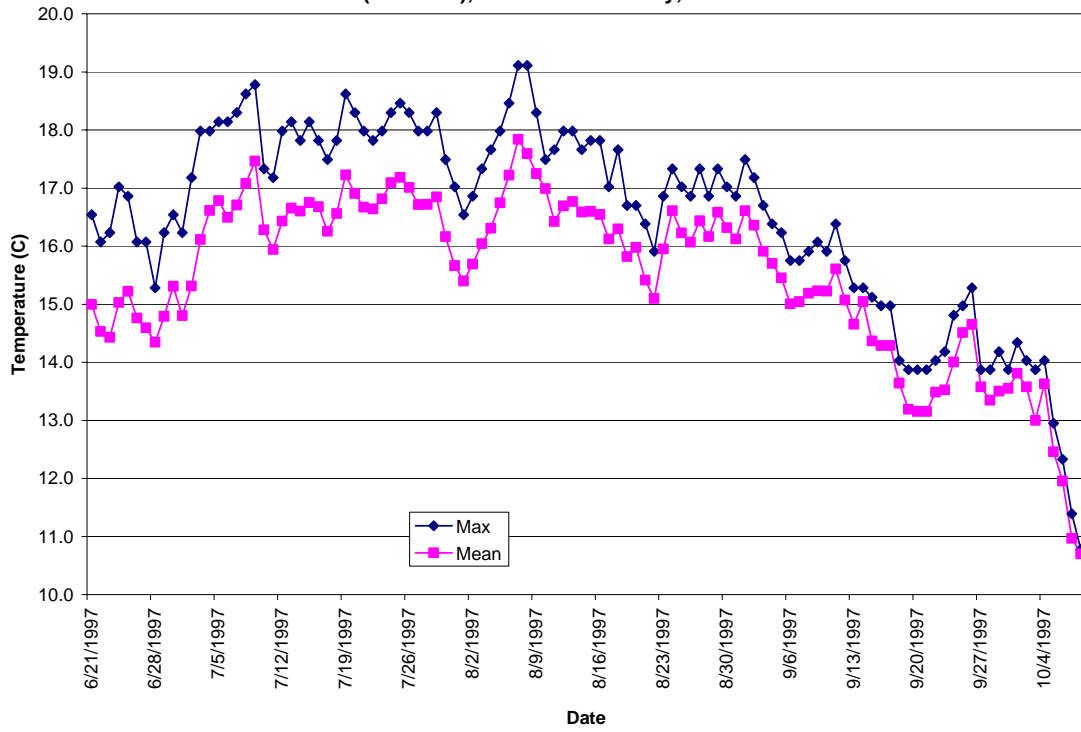
Figure 121. Mean and Maximum Daily Stream Temperatures During Summer 1997 at Greenwood Creek (Site 84-3), Mendocino County, California.

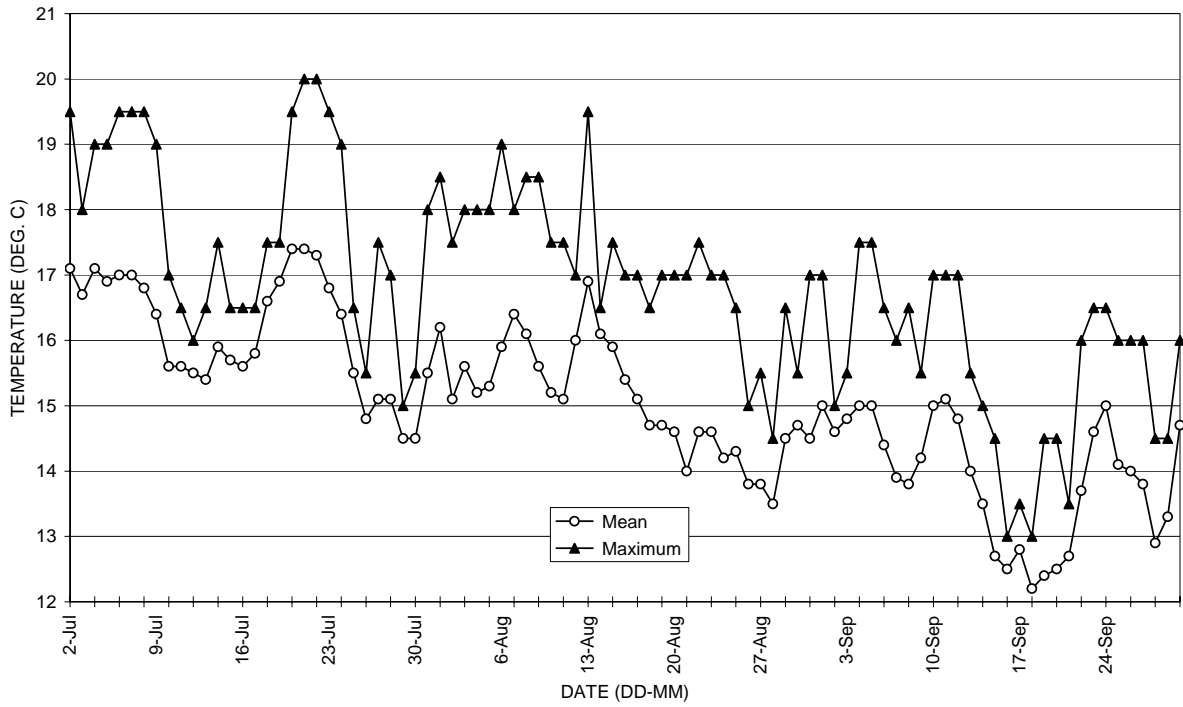
FIGURE 49. MEAN AND MAXIMUM DAILY STREAM WATER TEMPERATURES DURING SUMMER (JULY-SEPTEMBER 1992) AT GREENWOOD CREEK (MAP NO. 11; MONITORING SITE NO. 27), MENDOCINO CO., CALIFORNIA.
